Assessment of Preventative Biofouling Management Measures

MPI Technical Paper No: 2016/69

Prepared for Ministry for Primary Industries
By ESLINK Services

September 2016

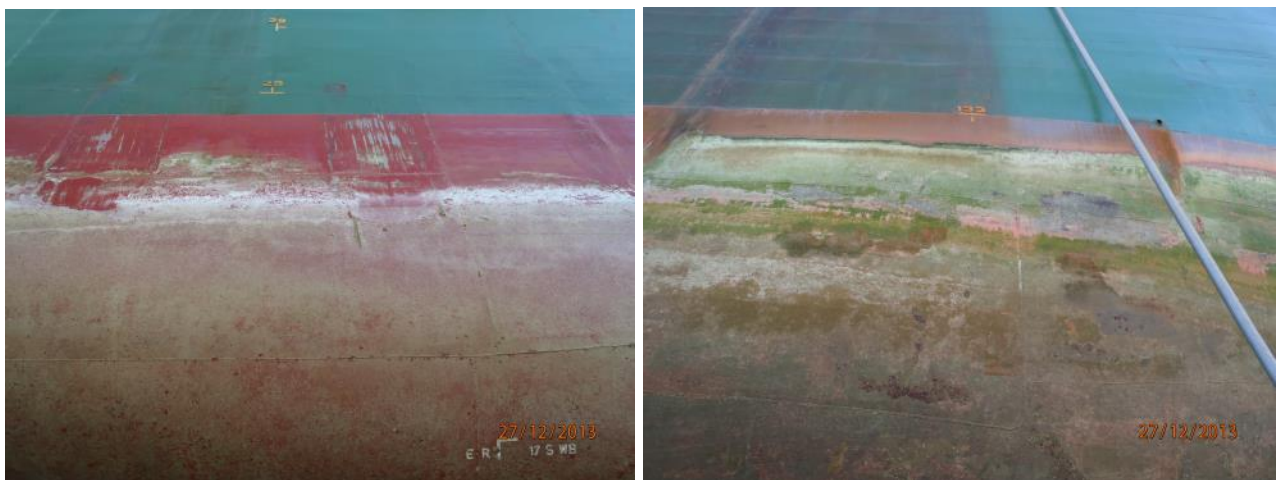
Figure 5. FRC on boottop and vertical sides at 23 months with only slime (primary biofouling).

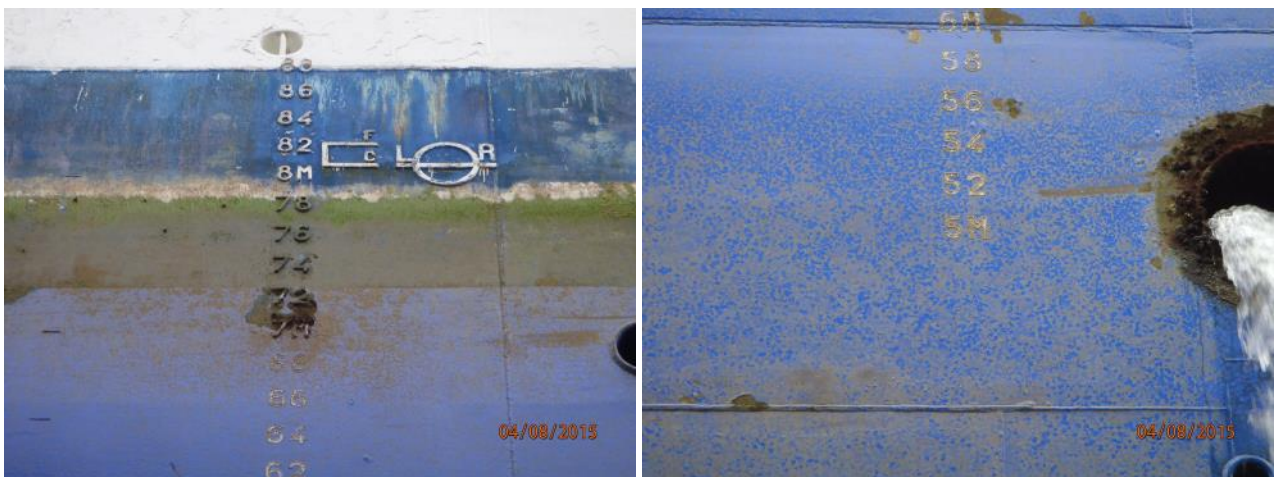
Figure 6. FRC (left) and CDP (right) on boottop and vertical sides of same vessel at 24 months with more extensive green algal fouling on the CDP.

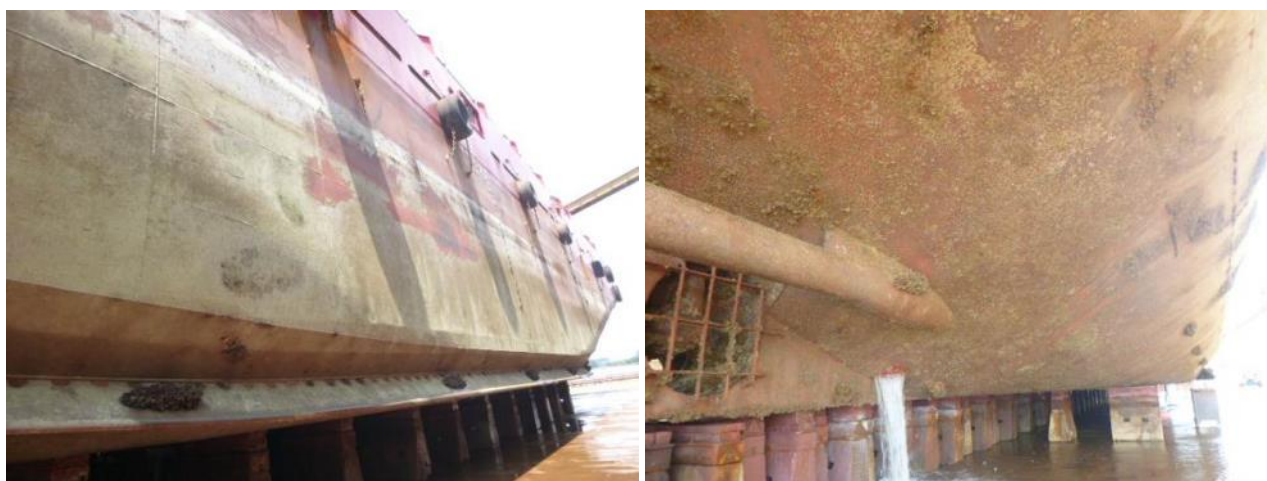
Figure 9. Scattered patches of goose and acorn barnacle fouling on CDP coating on one vessel at 15 months.

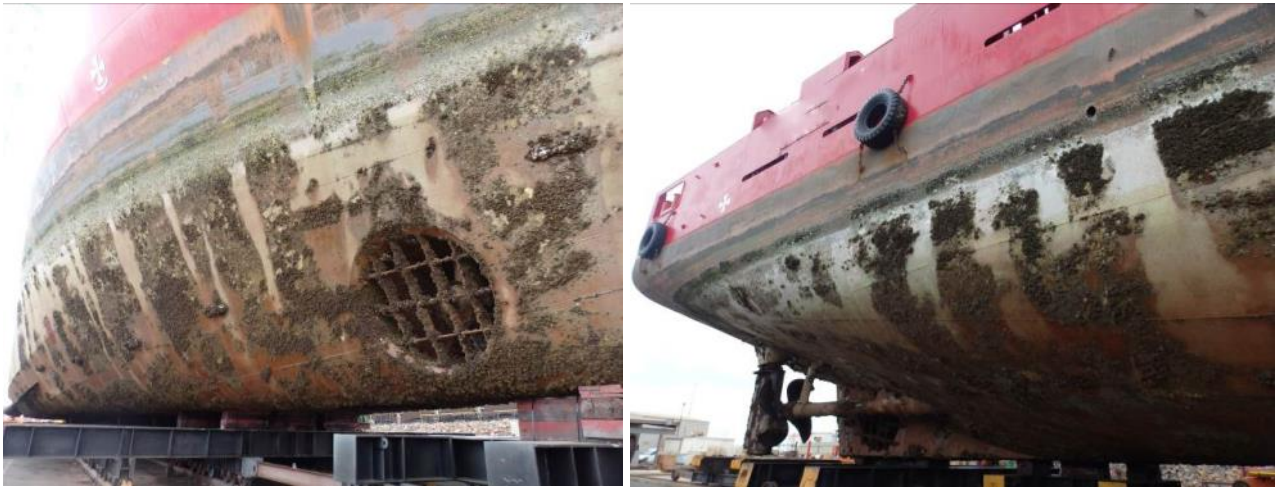
Figure 10. Extensive secondary⁶ fouling on CDP coating on one vessel at 30 months.

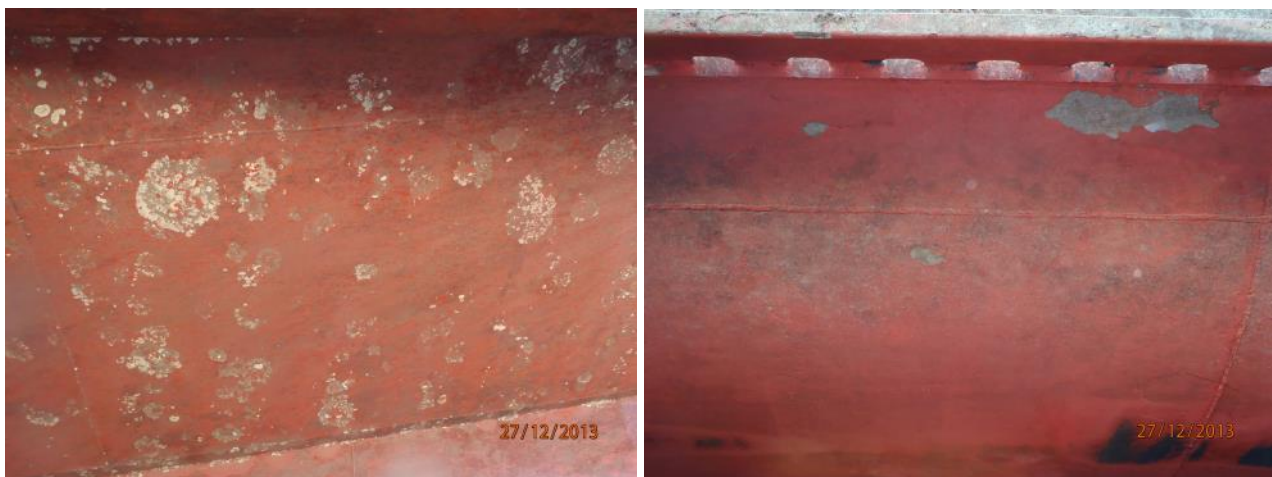
Figure 12. FRC at 36 months with only light slime.

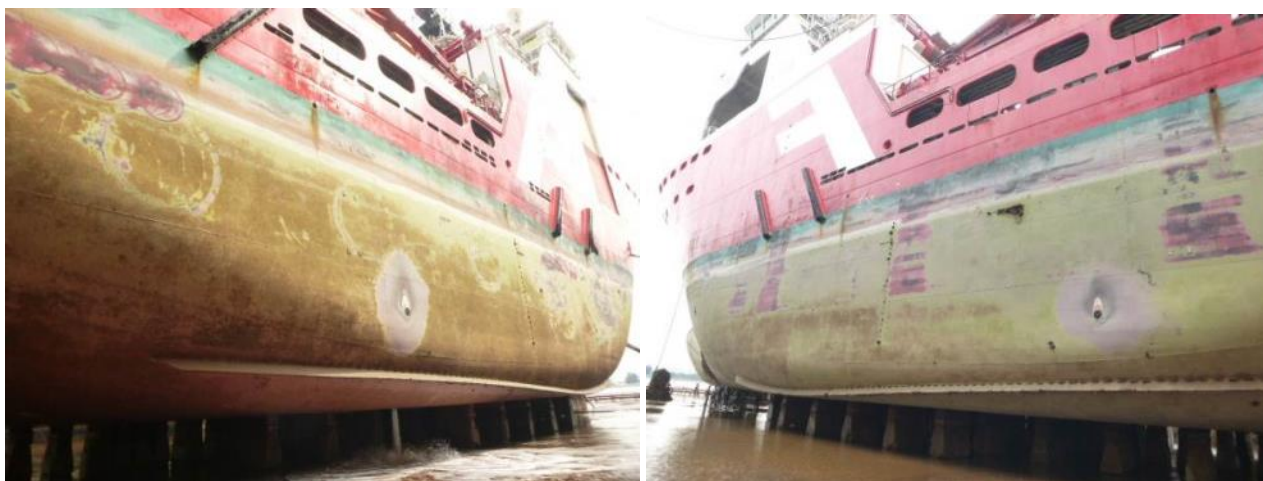
Figure 13. FRC (left) and CDP (right) on flats of same vessel at 24 months. Scattered encrusting bryozoan colonies were present on the FRC.

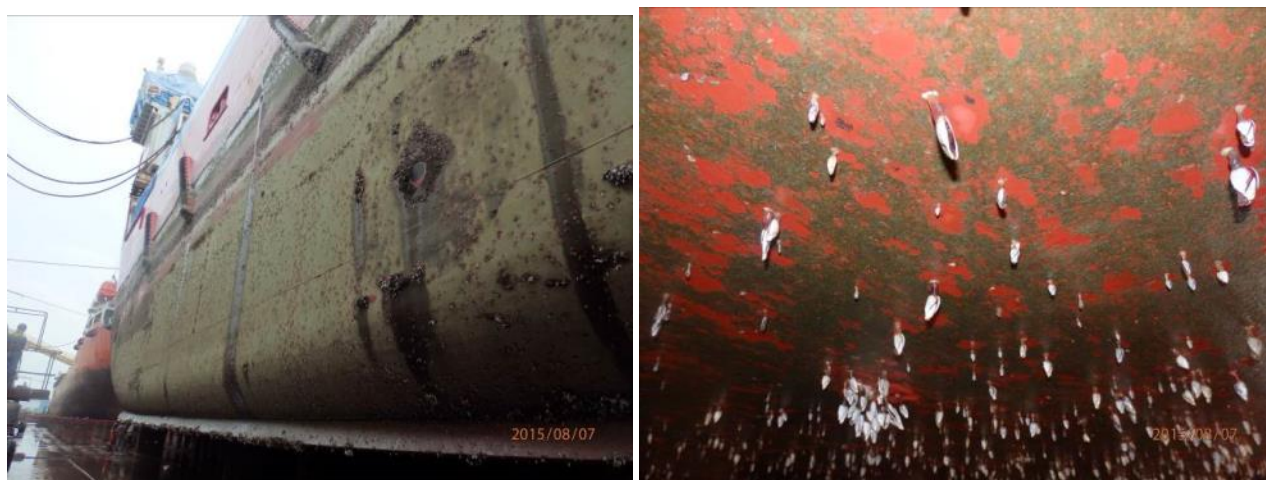
Figure 14. Slime on SPC on vertical sides of one vessel at 17 months.

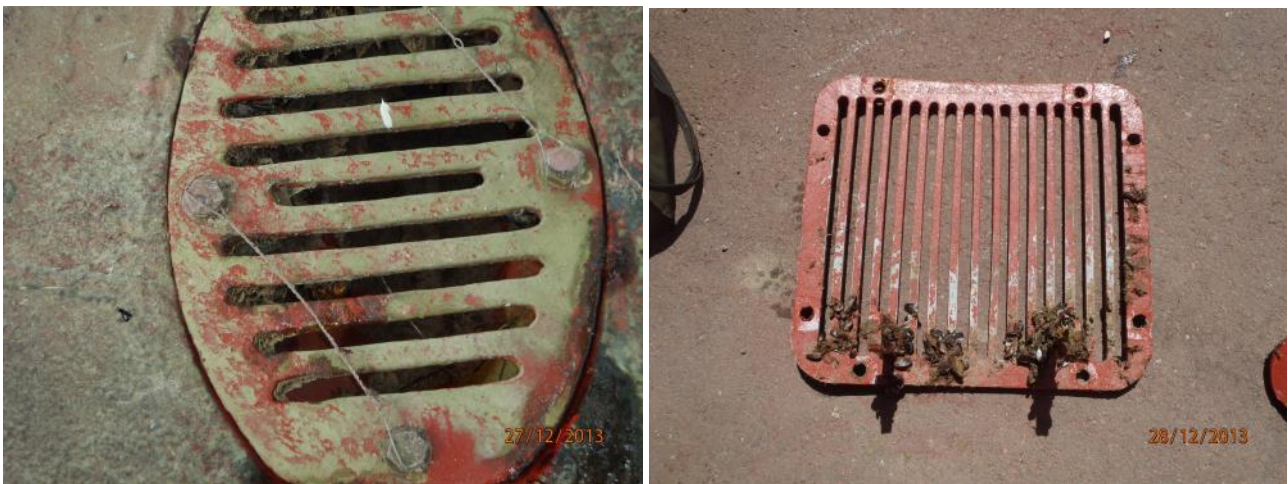
Figure 17. CDP-coated sea chest intake grates on vessels after 7 (left) and 15 (right) months service with acorn barnacles predominantly clustered along grate edges and between bars.

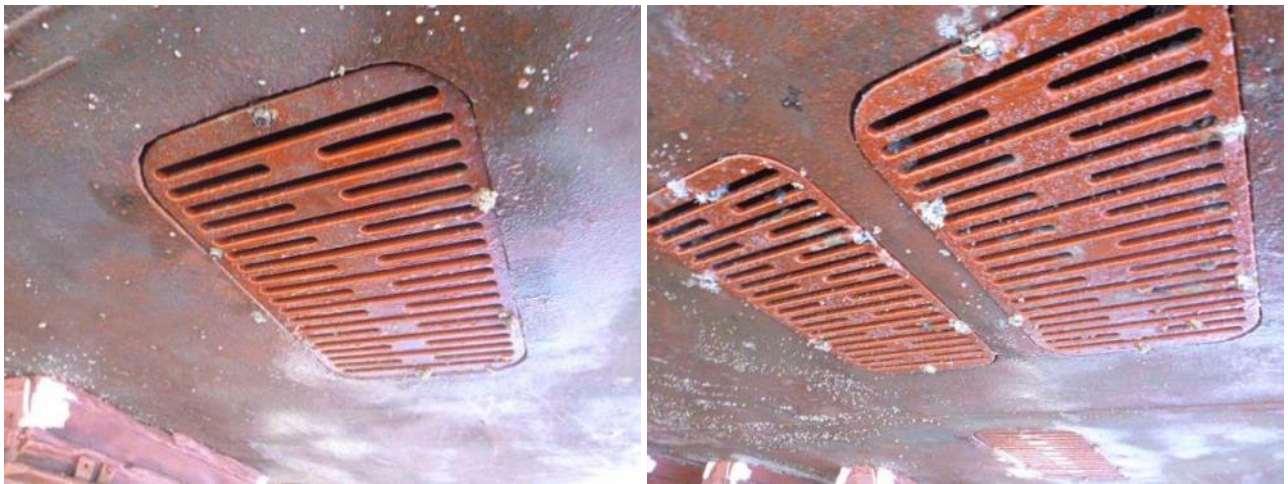
Figure 18. CDP-coated sea chest intake grate bars at 24 months with low abundance of macrofouling between bars.

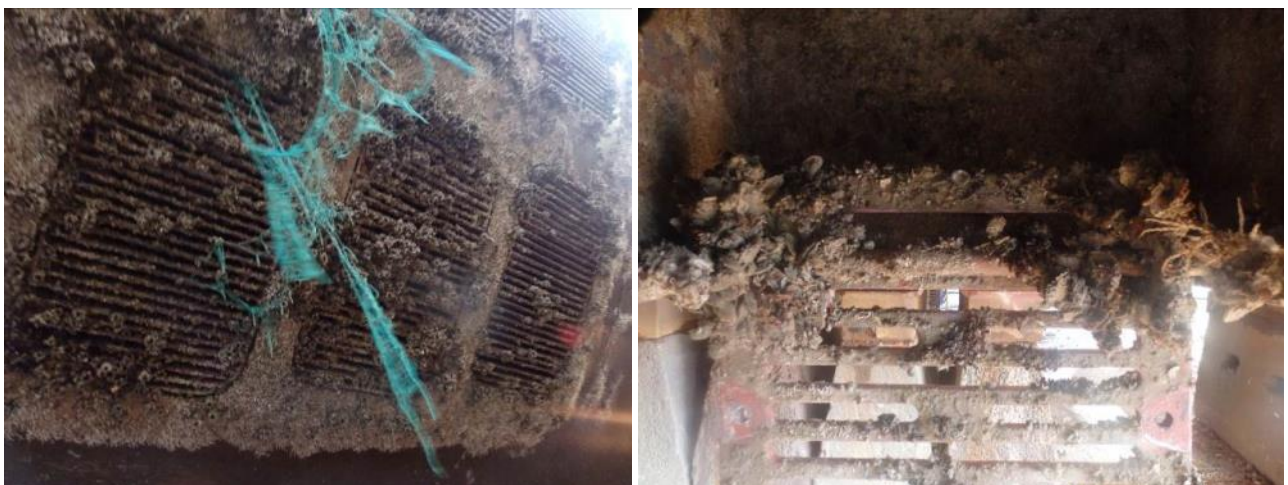
Figure 19. CDP-coated sea chest intake grate bars at 30 months with minimal macrofouling.

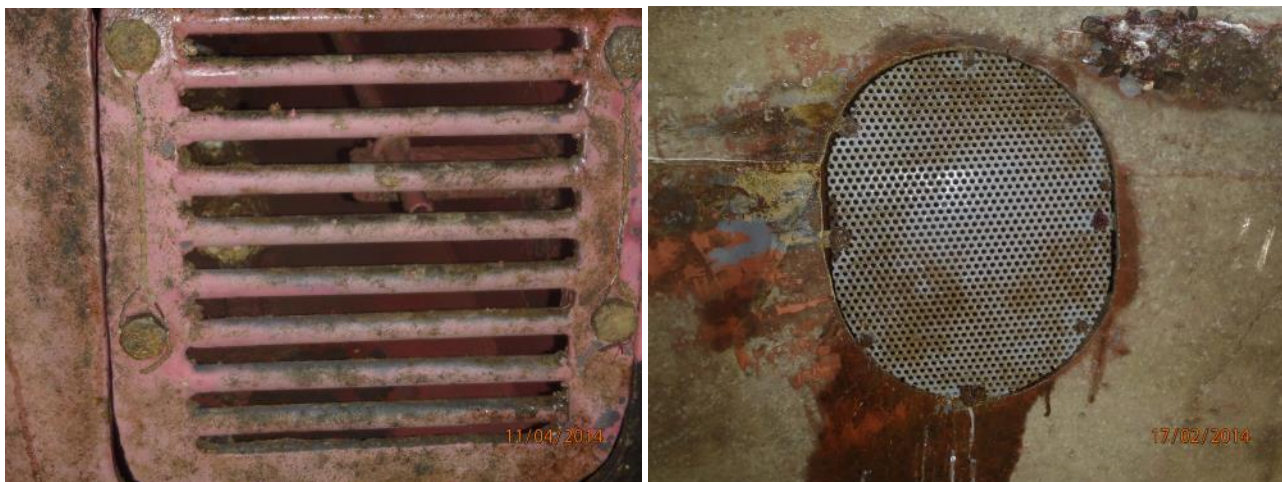
Figure 20. CDP-coated sea chest intake grate bars at 40 months with high abundance of macrofouling on, between and under grate bars.

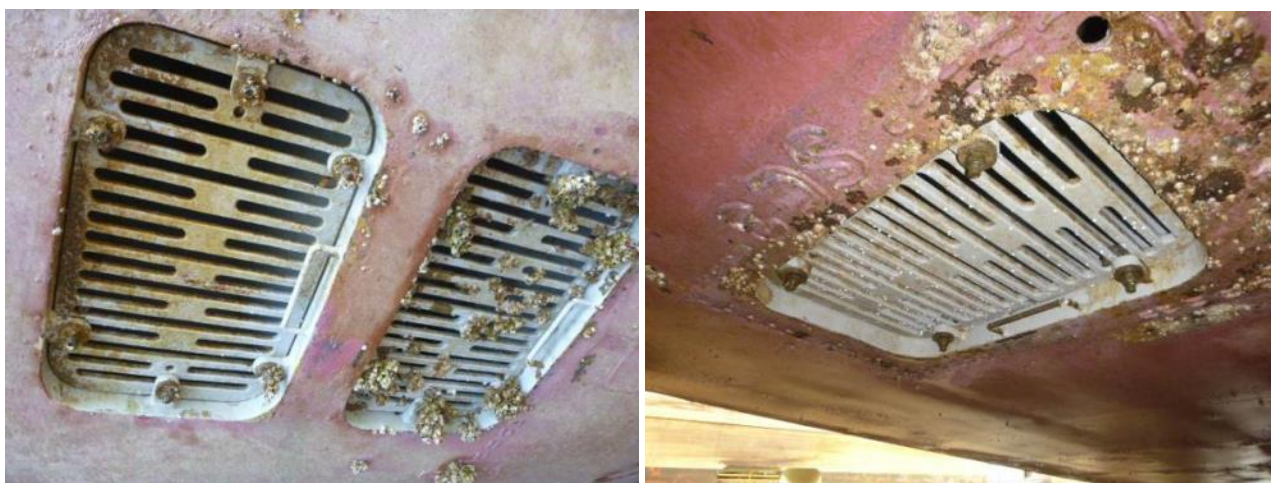
Figure 21. SPC- (left) and FRC (right) coated sea chest intake grates on two vessels with similar operational profiles, both with minimal macrofouling on the grates.

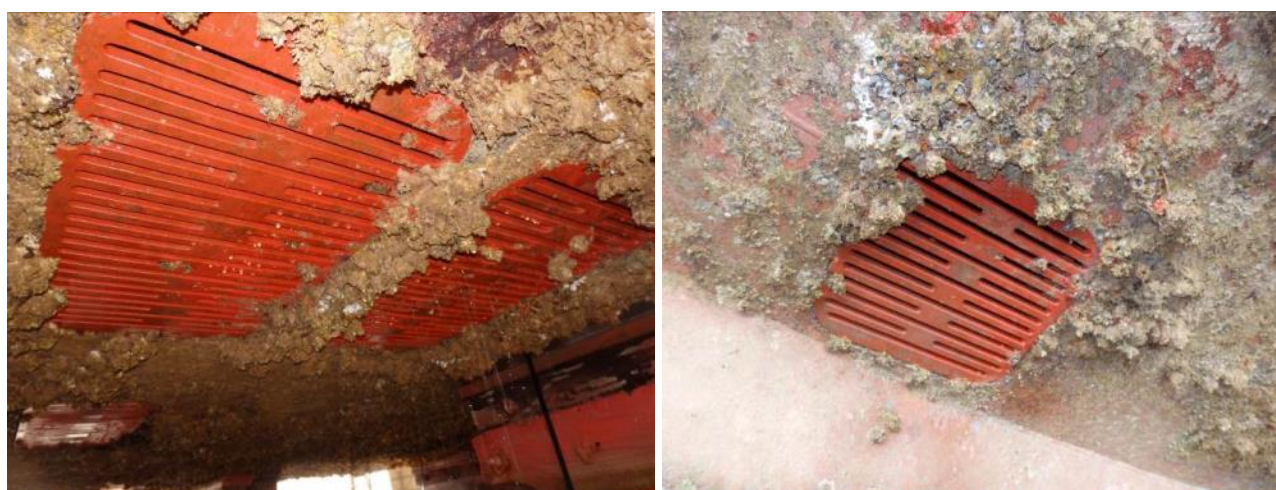
Figure 22. FRC coated sea chest intake grates on one vessel at 17 months with overall minimal macrofouling on and between bars.

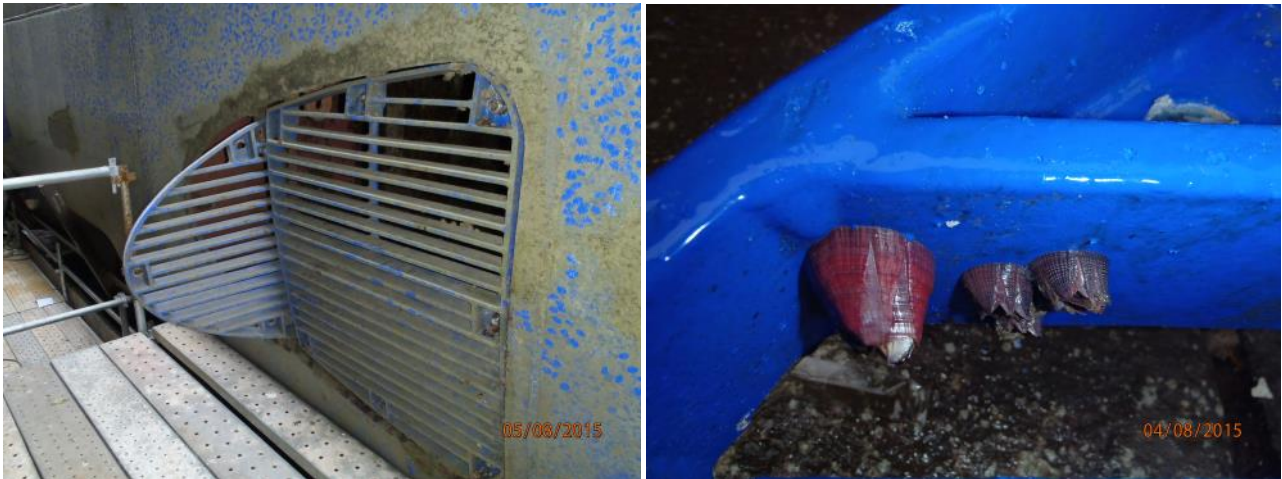
Figure 23. FRC coated sea chest intake grates at 36 months with minimal macrofouling despite extensive fouling on adjacent hull surfaces.

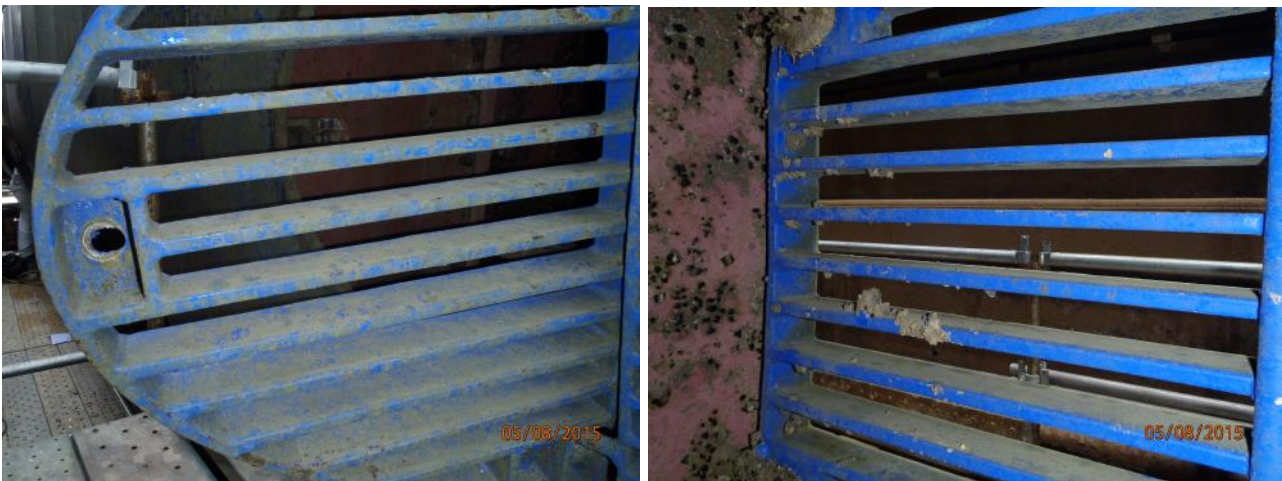
Figure 24. FRC-coated sea chest intake grate at 36 months with only a few barnacles on paint imperfections.

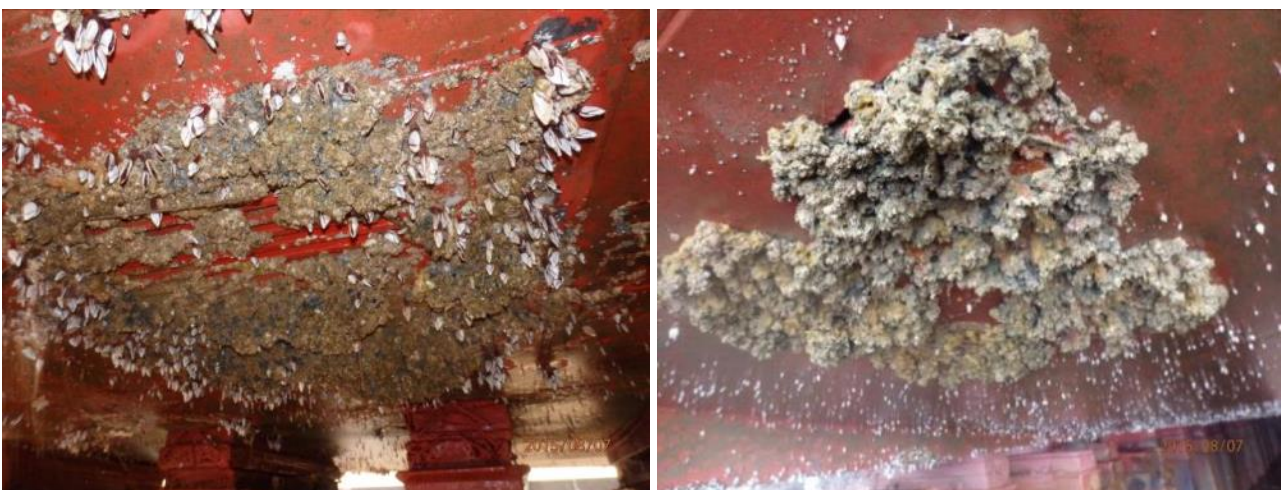
Figure 25. FRC-coated sea chest intake grate of same vessel as in previous figure showing bars almost free of macrofouling.

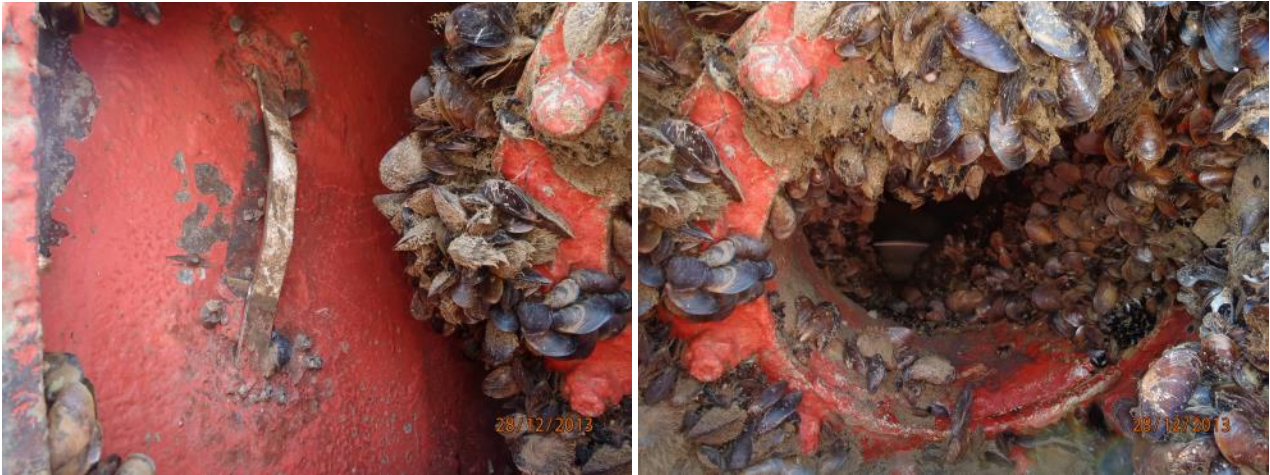
Figure 28. CDP1-coated sea chest on one vessel at 24 months showing minimal macrofouling on the chest wall (left) and heavy fouling on projections (left and right).

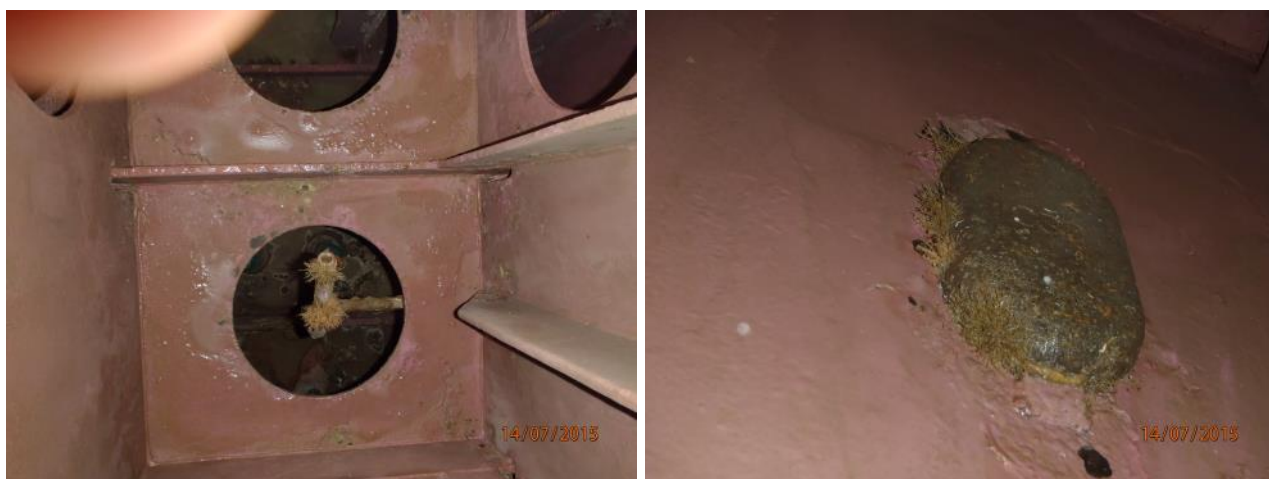
Figure 33. SPC1-coated sea chest at 23 months with macrofouling only on projections and unpainted anodes.

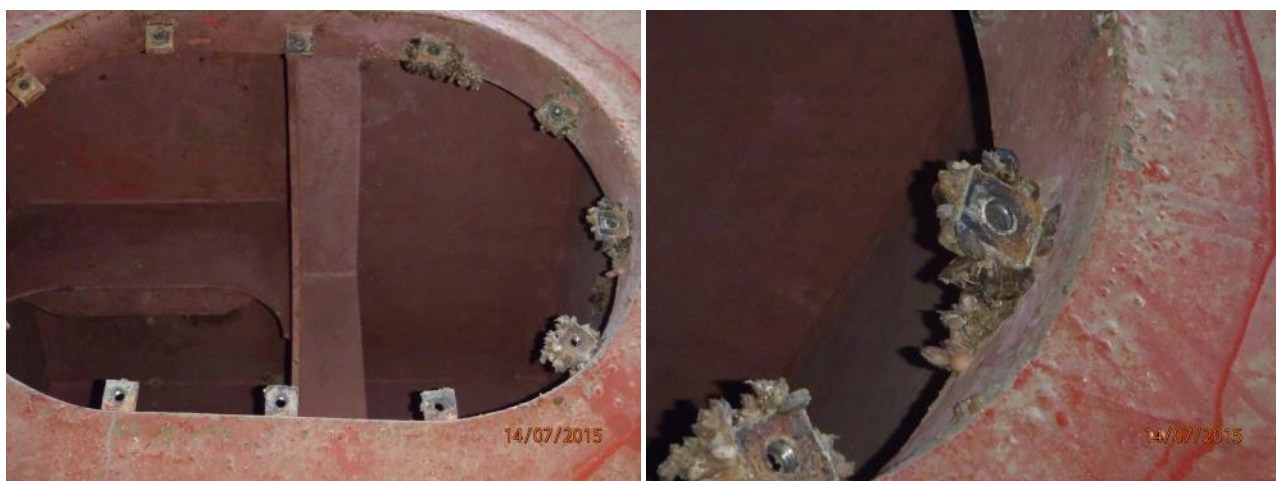
Figure 34. Another SPC1-coated sea chest on the same vessel as in Figure 33 showing macrofouling restricted to paint imperfections on grate attachment lugs.

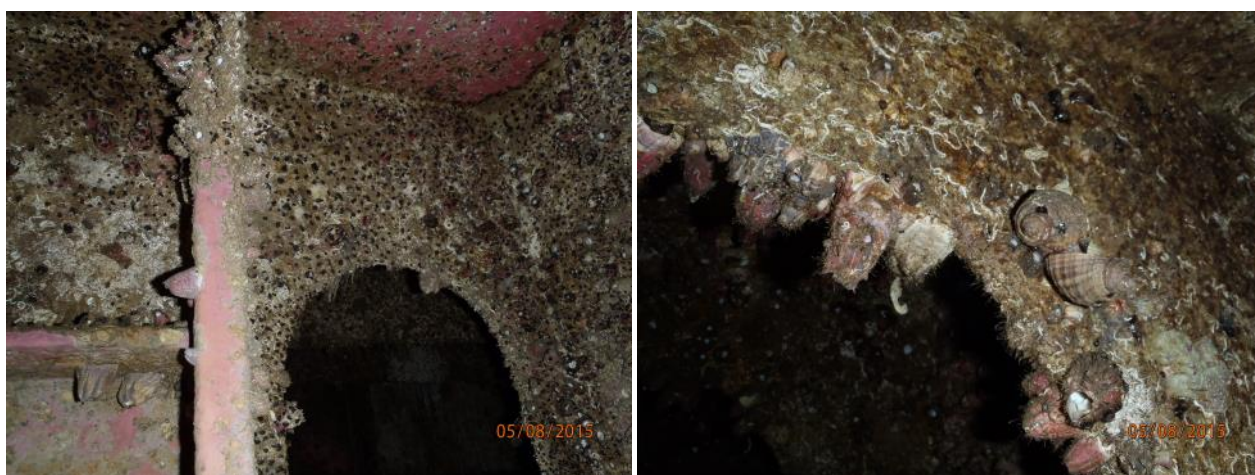
Figure 35. SPC2-coated sea chest at 36 months with extensive coverage of macrofouling on walls and tertiary stage⁷ biofouling on projections.

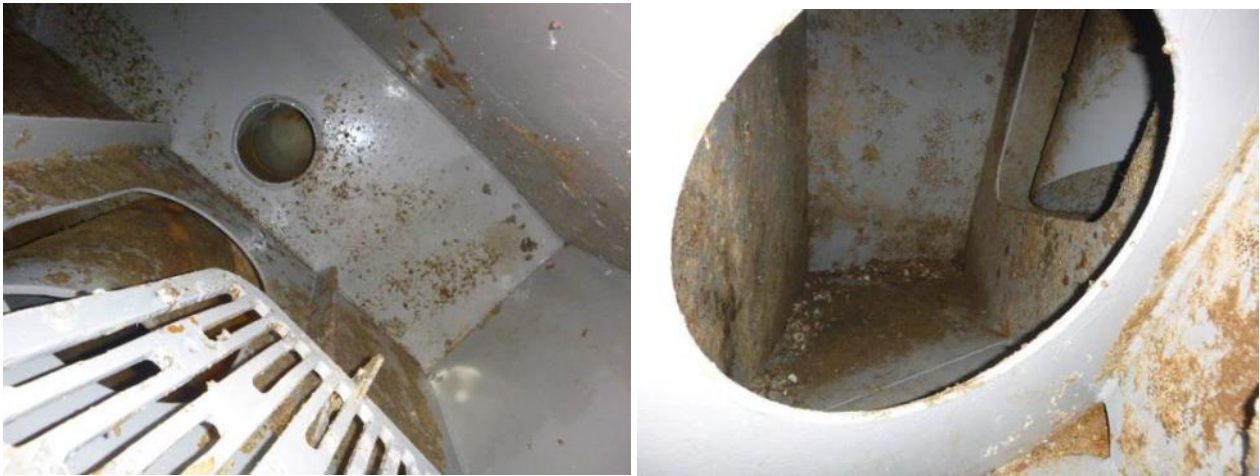
The performance of the FRC in sea chests was not dissimilar to that of CDP and SPC2 coatings (Figure 27). On one vessel, after 17 months in service, the coating appears to be in good condition, but there is a large percentage of wall surfaces covered by encrusting and short, soft fouling organisms (Figure 36).

Figure 36. FRC-coated sea chest at 17 months showing up to 50 % coverage of walls by encrusting biofouling.

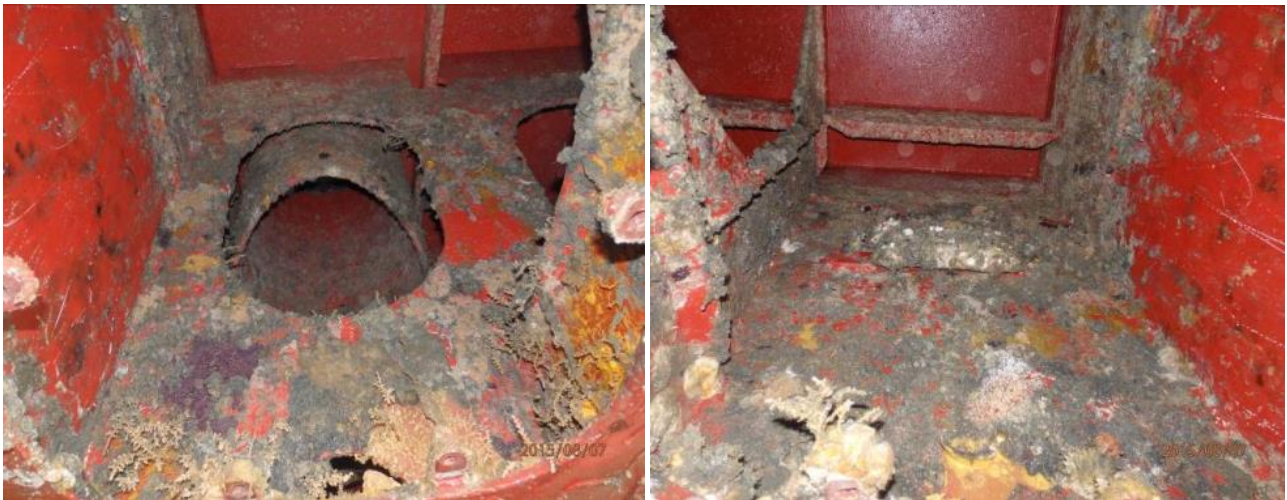
Figure 37. FRC-coated sea chest at 40 months. Some walls have almost no attached macrofouling while others are extensively covered.

On one vessel, some sea chest walls were extensively covered by biofouling, while other walls in the same sea chests were not (Figure 37). This could not be explained by variable flow through the sea chest because one entire wall was fouled. The most likely cause of this is inconsistent FRC application, with a lower paint thickness applied to the fouled walls, highlighting the importance of good coating application at a suitable thickness on all surfaces within sea chests. One vessel was observed in which the sea chest walls had less biofouling on inner wall surfaces than on the outer hull plate. The information provided for this vessel showed that additional antifouling had been applied within the sea chests because of their higher biofouling susceptibility.

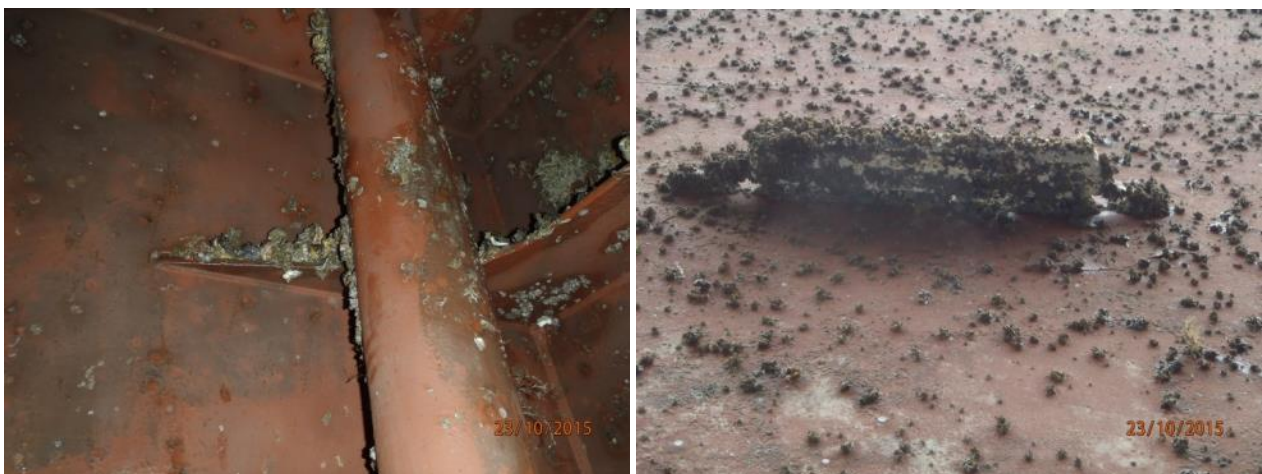
Figure 38. Vessel after 7 months in service with CDP1 coating performing better inside the sea chests than on the outer hull.

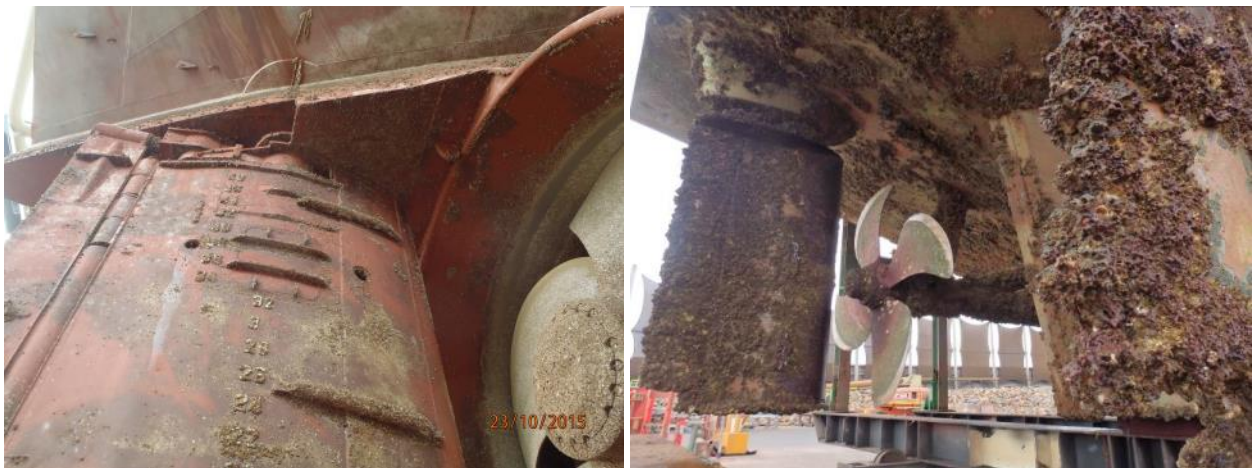
Figure 39. CDP-coated rudders on vessels after 7 (left) and 40 (right) months service showing the development of biofouling over time.

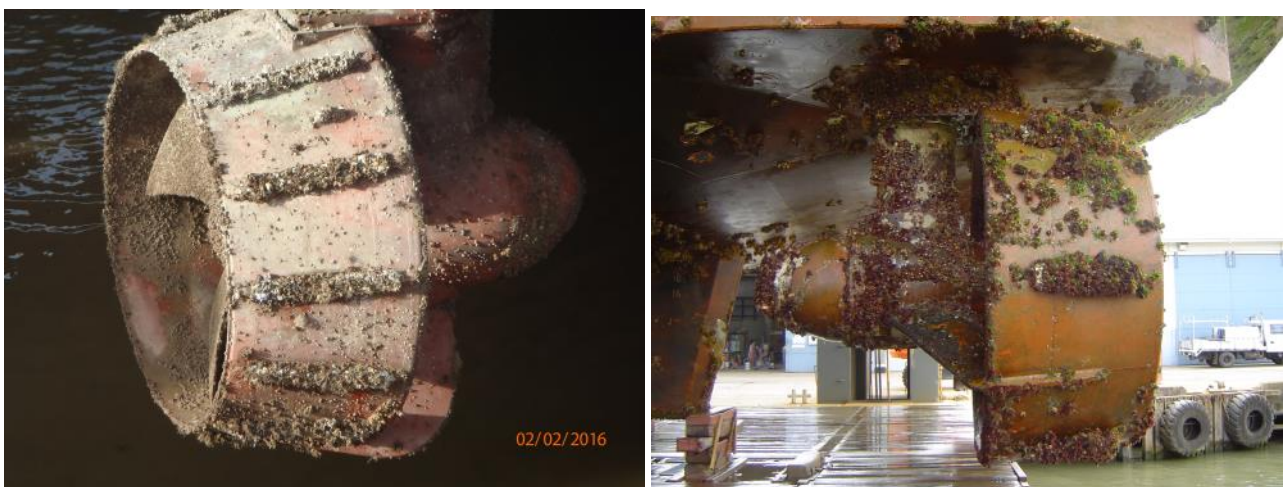
Figure 40. CDP-coated Schottel propulsion units on two vessels after 13 (left) and 36 (right) months service, both with scattered macrofouling on paint surfaces and substantial fouling on anodes and paint imperfections.

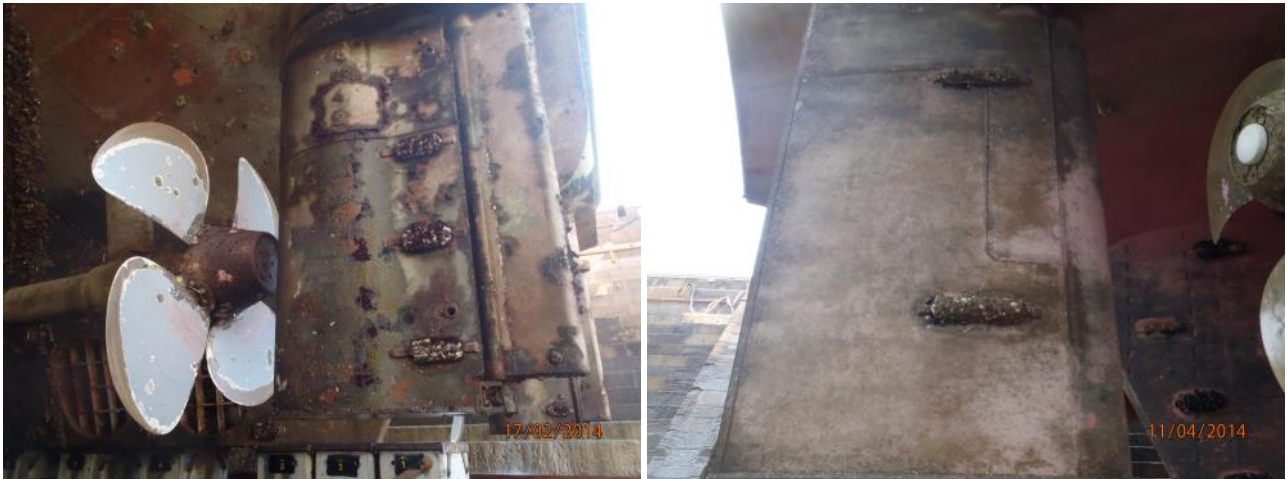
Figure 41. CDP- (left) and SPC- (right) coated rudders on two vessels with similar operating profiles showing less macrofouling on the SPC.

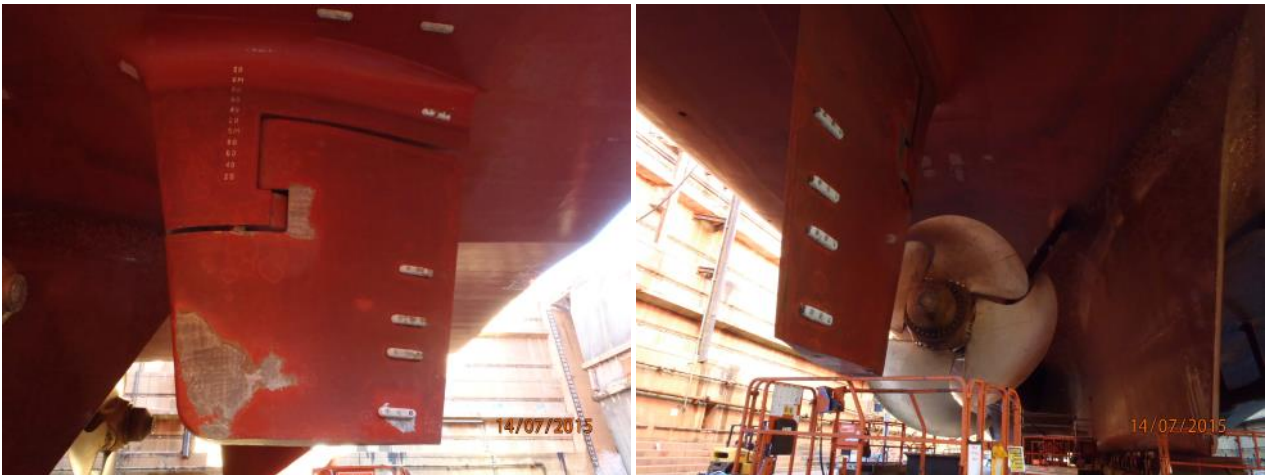
Figure 42. FRC-coated rudders on two vessels at 24 months showing absence of visible macrofouling.

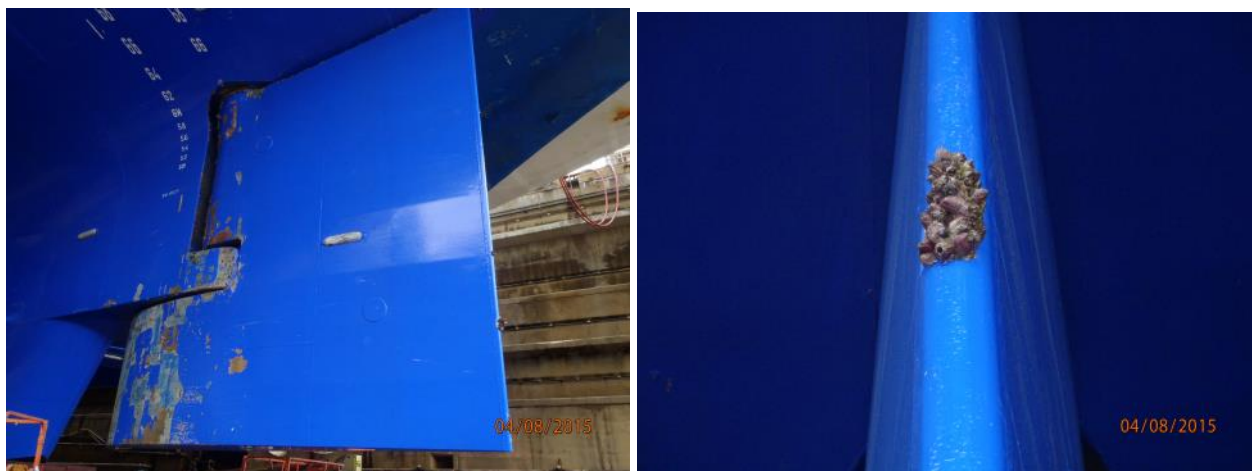
Figure 43. FRC-coated rudder at 36 months with macrofouling confined to areas of paint damage.

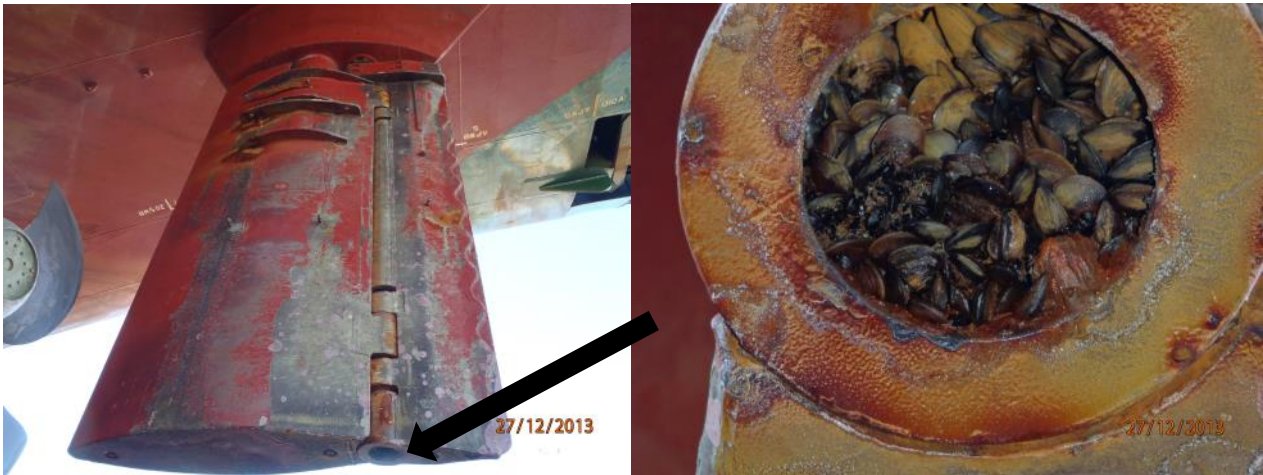
Figure 44. FRC-coated rudder at 24 months with little macrofouling on rudder surfaces but substantial mussel growth in the lower pintle recess (arrowed).

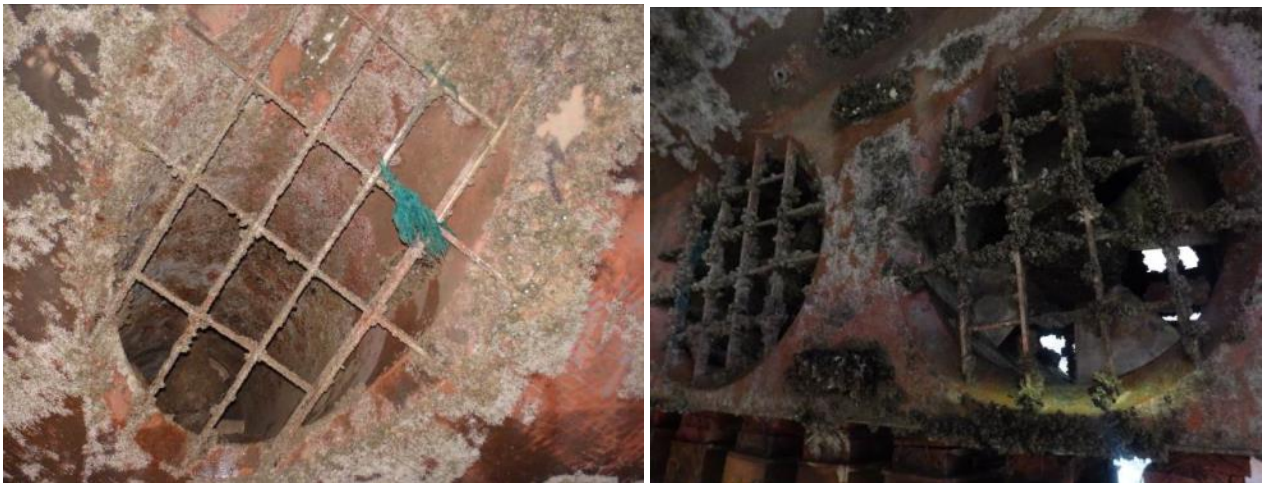
Figure 47. CDP painted thruster tunnels and tunnel grates after 40 months showing extensive macrofouling establishment on grate bars and tunnel walls.

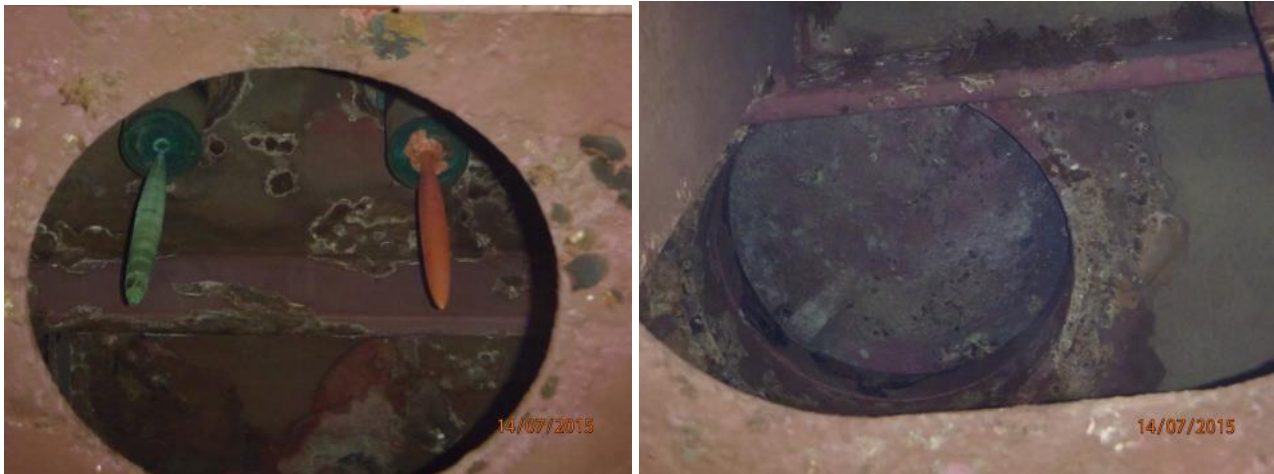
Figure 51. Copper and aluminium MGPS anodes inside a sea chest with a “soft” SPC coating after 24 months service with low abundance of macrofouling on the chest walls.

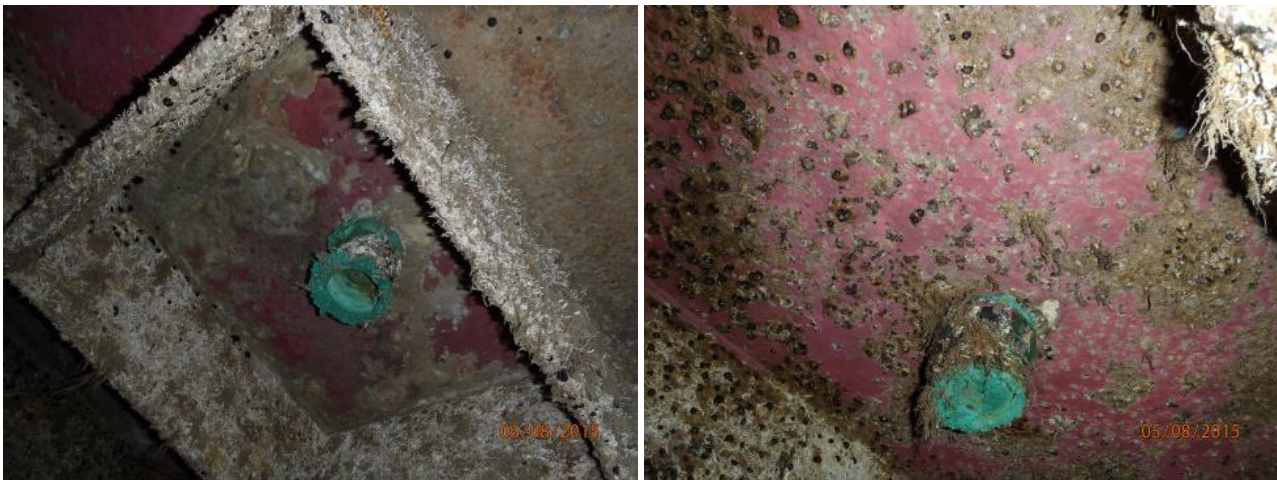
Figure 52. Depleted copper anodes inside a sea chest with a “hard” CDP coating after 36 months service, showing extensive macrofouling on the chest walls and projections.

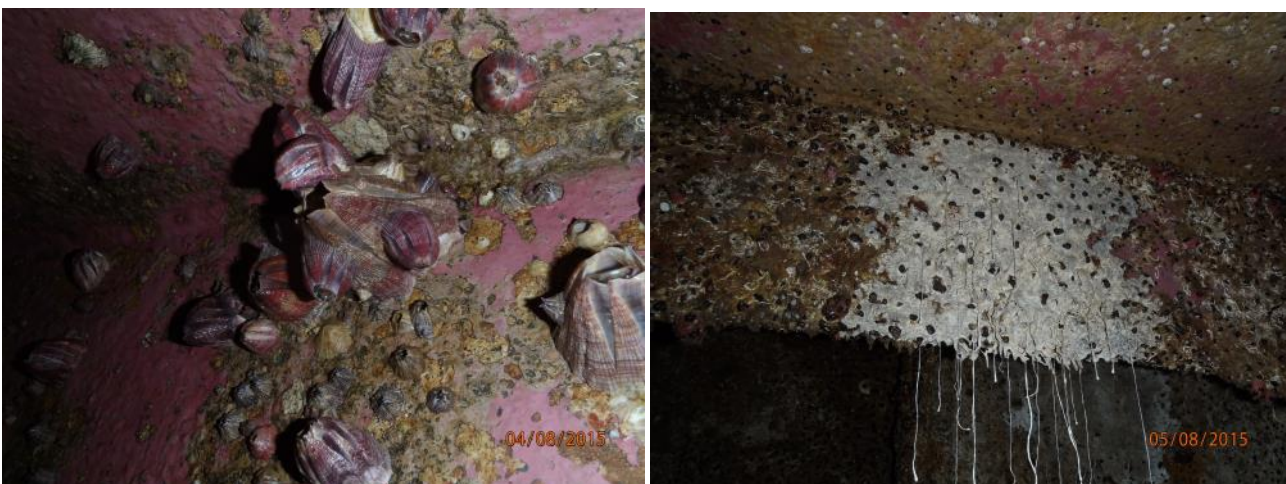
Figure 53. Megabalanid barnacles (left) and a didemnid ascidian colony (right) in the same sea chest as in Figure 52.

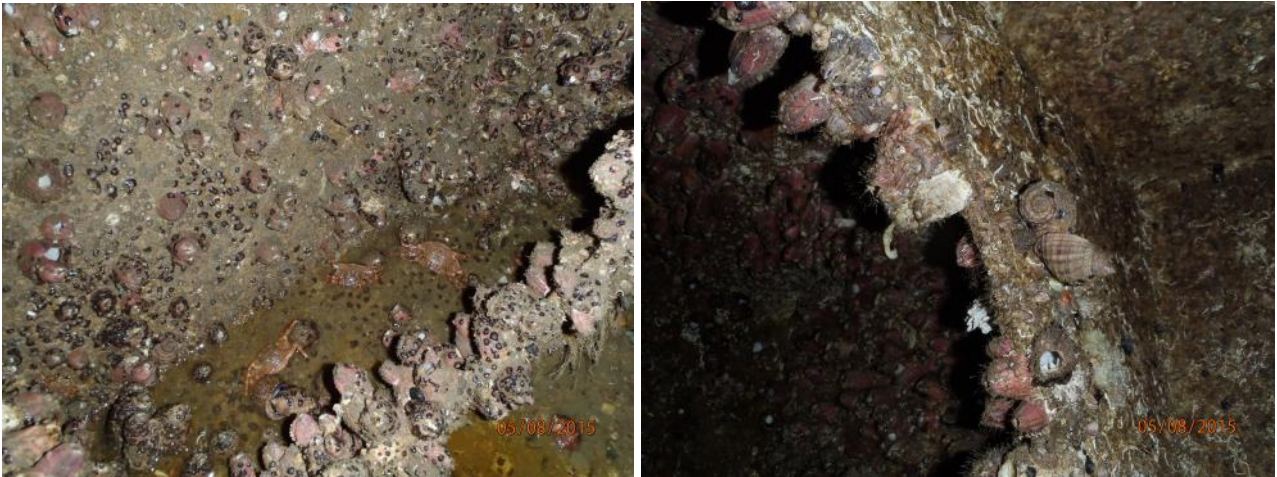
Figure 54. Tertiary stage biofouling, including crabs (left) and dog whelks (right) in the same sea chest as in Figure 52.

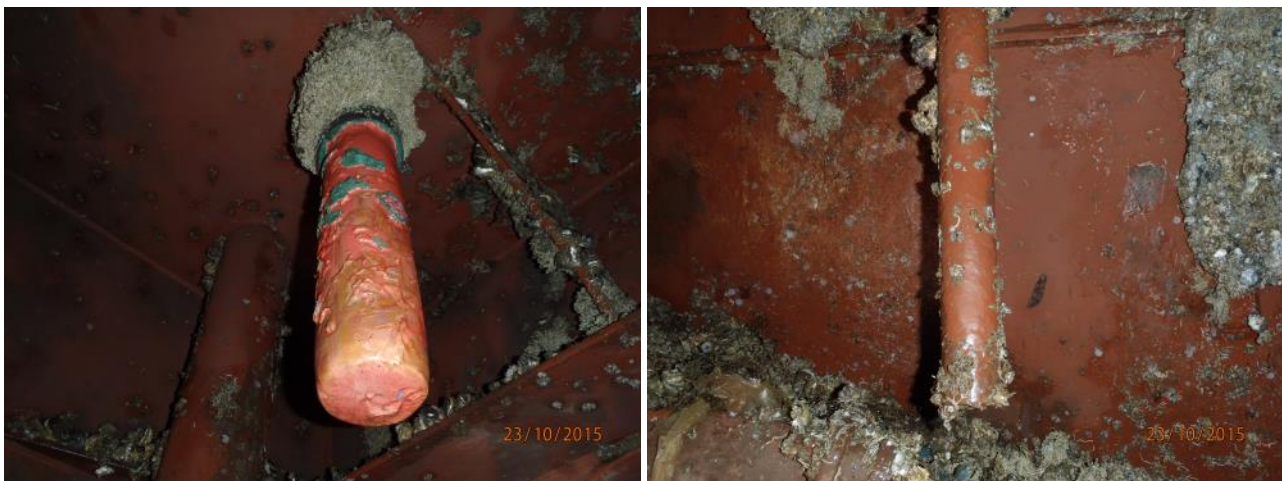
Figure 55. Biofouling in a sea chest fitted with a copper anodic MGPS after 7 months service showing a tubeworm collar around the base of an anode (left) and secondary fouling on an anode and projections (right).
