Assessment of Preventative Biofouling Management Measures

MPI Technical Paper No: 2016/69

Prepared for Ministry for Primary Industries
By ESLINK Services

September 2016

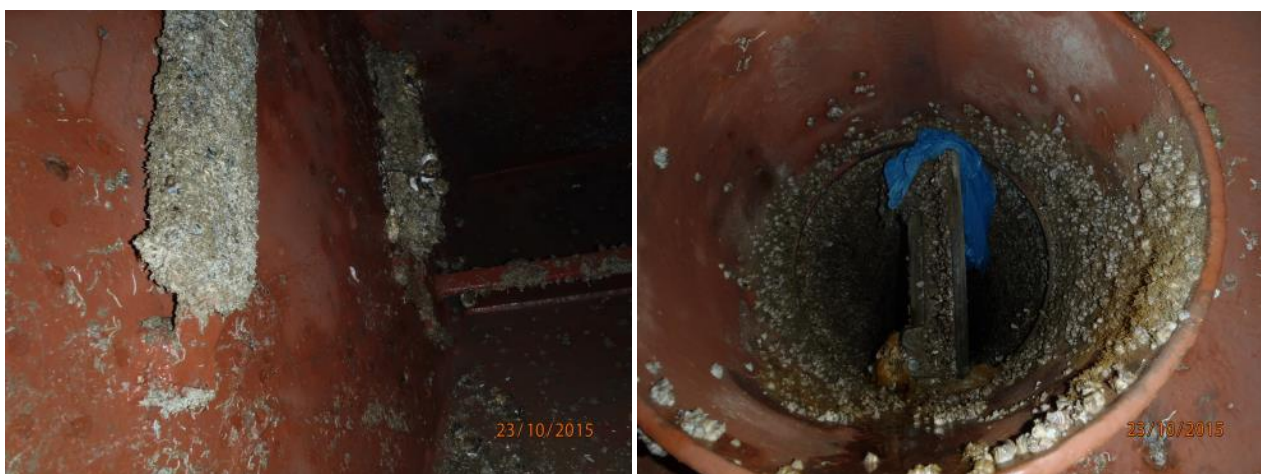
Figure 56. Biofouling on anodes and inside the intake of the same sea chest as in the previous figure.

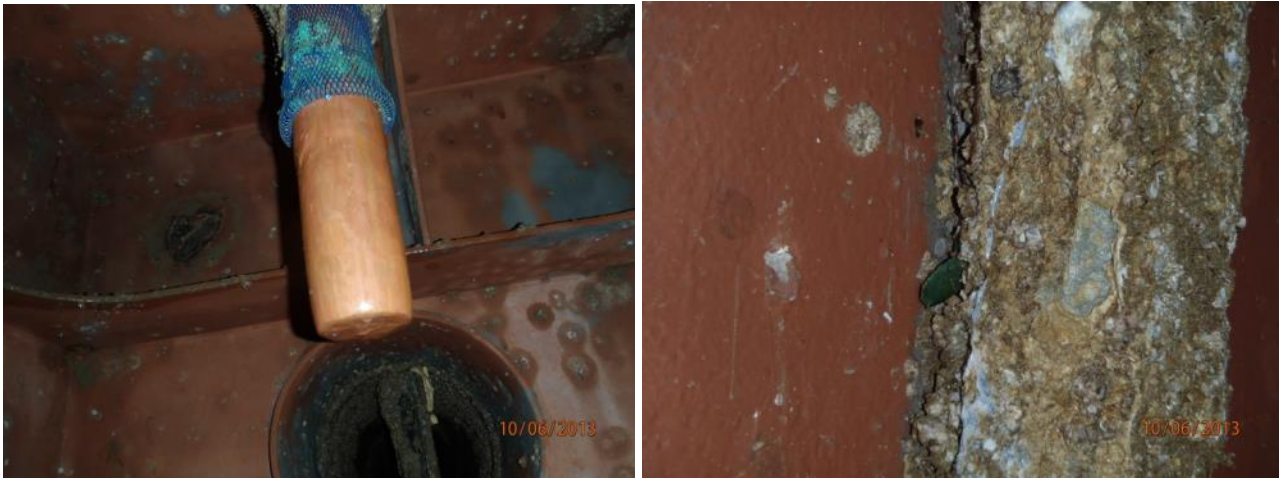
Figure 57. Sea chest on the same vessel as in the previous figures, but at an earlier docking. Note the growth on inner walls of the unpainted intake pipe and under the anode (including Asian green mussel (*Perna viridis*)).

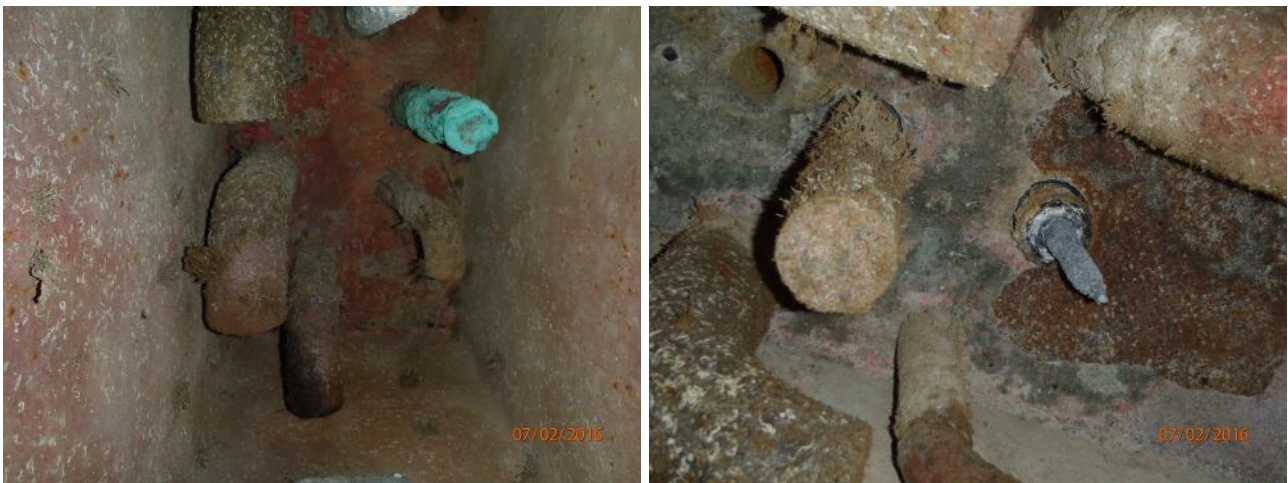
Figure 58. MGPS anodes inside sea chest of a Southern Ocean fishing vessel with tubeworms on chest walls and hydroids and tubeworms on projections.

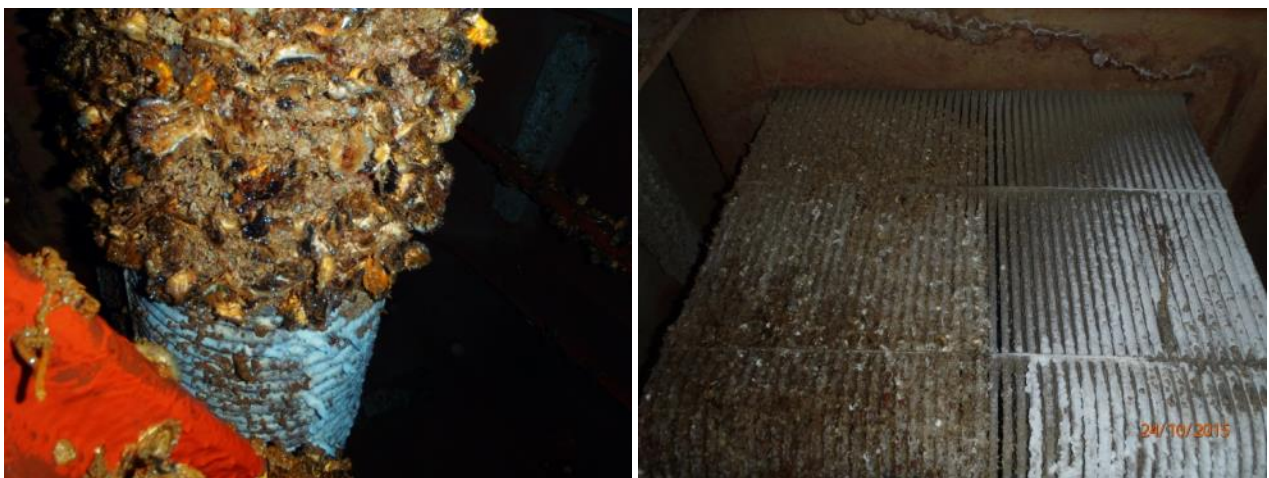
Figure 60. Box cooler after 7 months operation with substantial macrofouling on “cool” half, and only inorganic chalk on the “hot” half.

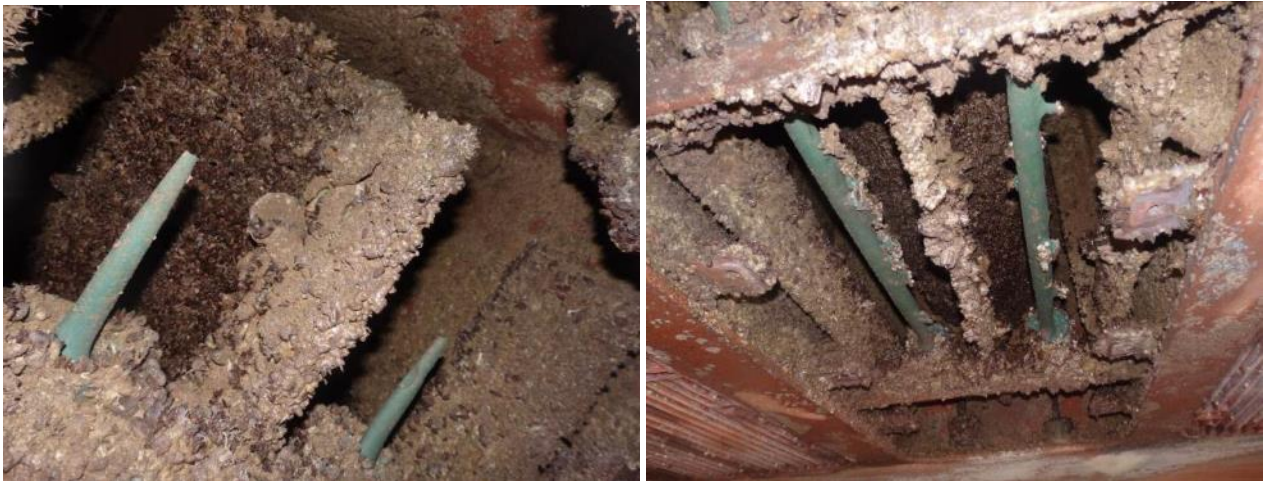
MGPSs have been designed for box coolers with copper anodes aligned under the coolers (Figure 61). The antifouling effect of such a system appeared ineffective in the one vessel with such a system observed in this study (Figure 62).

Figure 62. Box cooler with copper anodic MGPS after 40 months, with extensive macrofouling on all surfaces except for the anodes themselves.

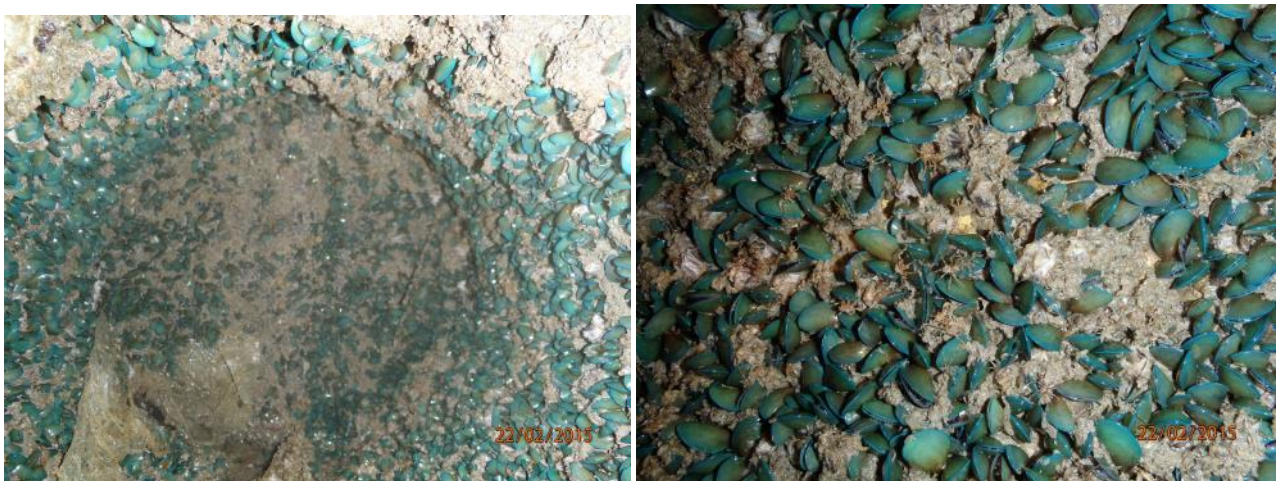
Figure 66. AGM and other living biofouling inside the strainer box in Figure 65.

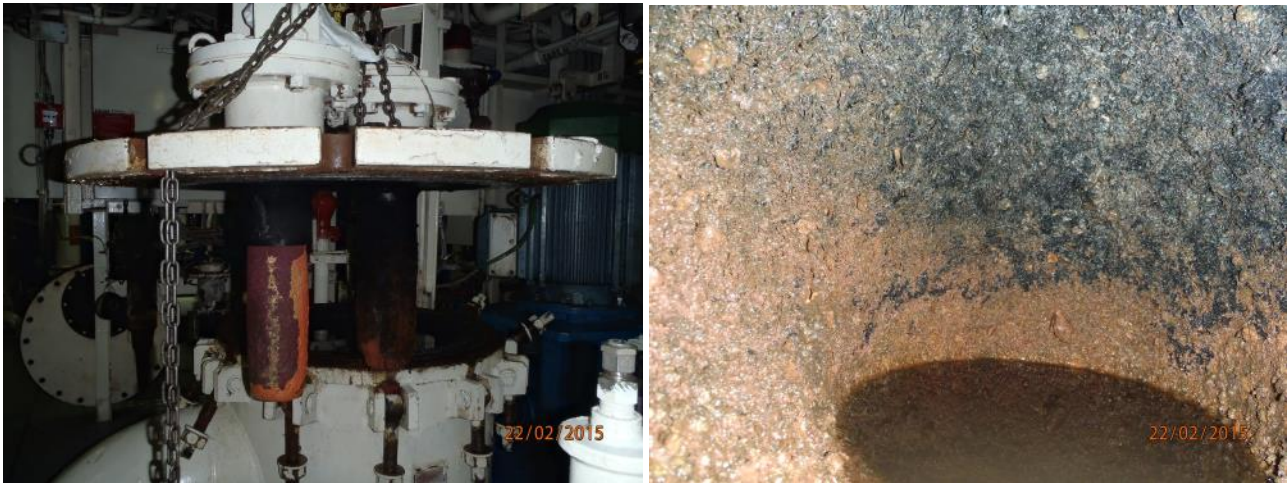
Figure 67. The low intake strainer box on the same vessel as Figure 66 with no viable fouling present.

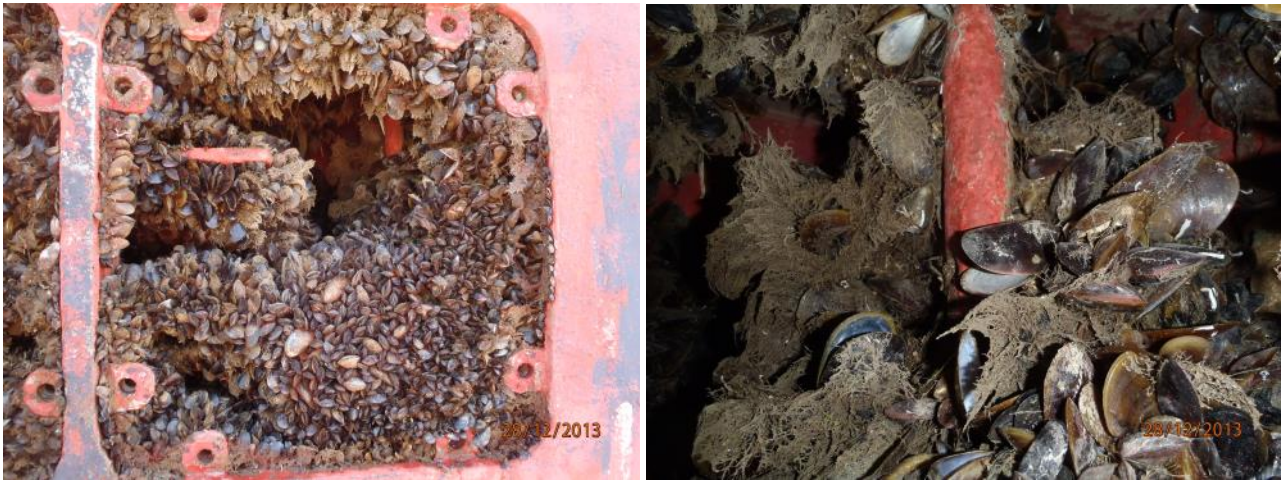
Figure 69. Mussels in the chemically dosed sea chest, including around the dosing pipe.
