AUDIT REPORT

TONGA

OBSERVATIONAL AUDIT OF THE HIGH TEMPERATURE FORCED AIR (HTFA) TREATMENT PATHWAY FOR THE EXPORT OF APPROVED FRUIT FLY HOST COMMODITIES TO NEW ZEALAND

07 February 2014

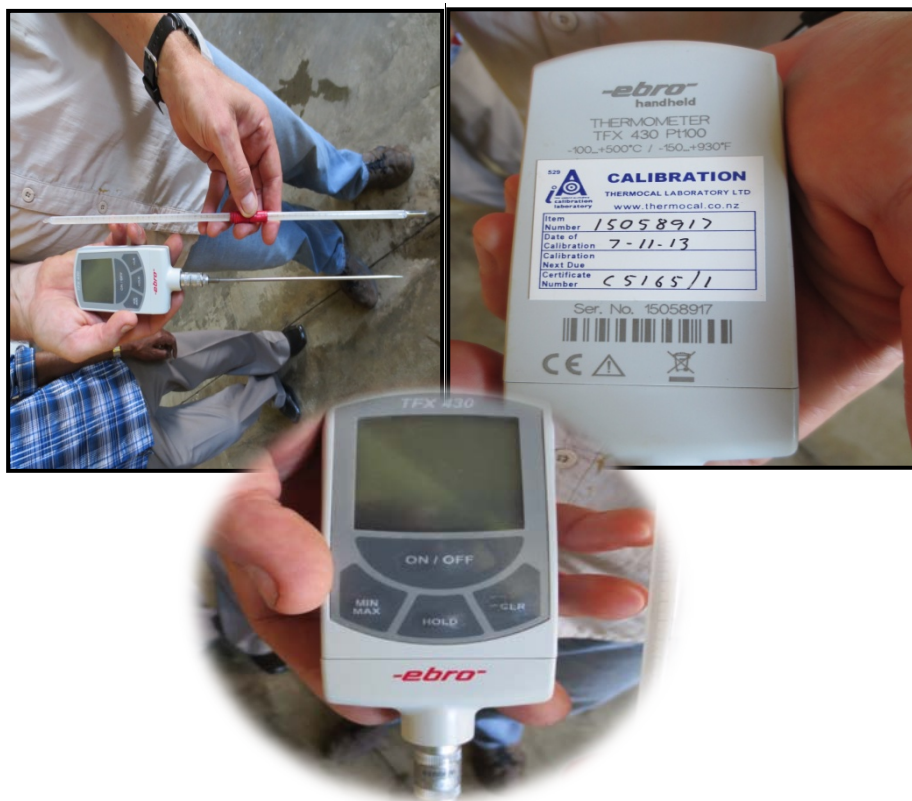
- 4.0 It was also reported that the mercury glass thermometer is two years out of warranty calibration.

New digital thermometer now being used replacing the old mercury thermometer

- 4.2 As a result of the significant difficulty and price regarding the freight and calibration services for mercury (hazardous substance) filled glass thermometers, a replacement digital thermometer has been sourced from New Zealand and calibrated. It has also since been utilised to perform successful group probe calibration. A group probe calibration was supervised by a Tonga MAF quarantine officer as part of a trial run.

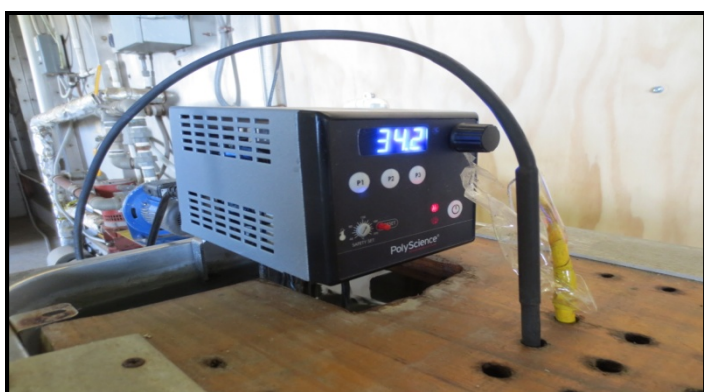
- 4.3 Water-bath and more importantly the heater/circulator for calibration have been confirmed to be non-operational and also beyond repair.

New water bath now used at the facility.

- 4.5 *A new replacement Immersion heater has been sourced from the USA. It has since been utilised to perform successful group probe calibrations, witnessed by MAFFF Tonga. The new replacement will ensure compliance with the current requirements from MPI.*

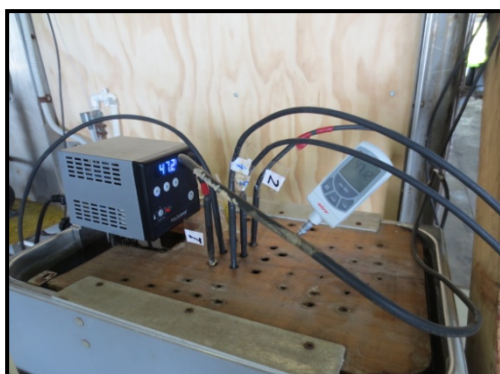
House probes being calibrated against the new digital thermometer

- 3.9 LH Chamber probe 3 and the dry bulb sensor have now been replaced and successful probe calibration performed. Please refer to attached image for new probe off sets.

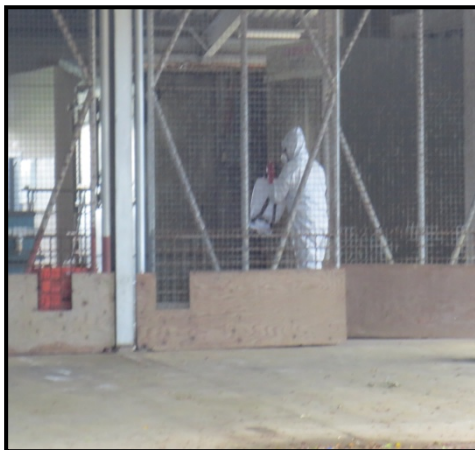
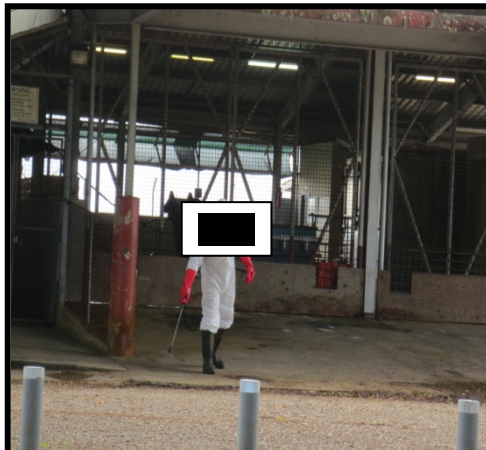
6.0 Even though, the HTFA hygiene register showed that the facility (interior and exterior) had been consistently sprayed with approved pesticide, live ants were still observed foraging on the floor and walls of the quarantine area including live spiders too.

Spraying of HTFA facility
(outside and inside)

- 6.3 Noted and agreed with the non compliance.
- 6.4 An employee [REDACTED] was re-engaged and sprayed the facility (interior and exterior) under QQMD supervision.
- 6.5 A heavily bearing papaya plant which grew close to the quarantine area of the facility (inside airport area) was also cut and removed by the airport authorities.

- 6.6 MPI re-inspected the quarantine area of the facility (*inside and outside*) and no further live ants or spiders were observed in the quarantine area of the facility. The removal of the papaya plant was noted by MPI.

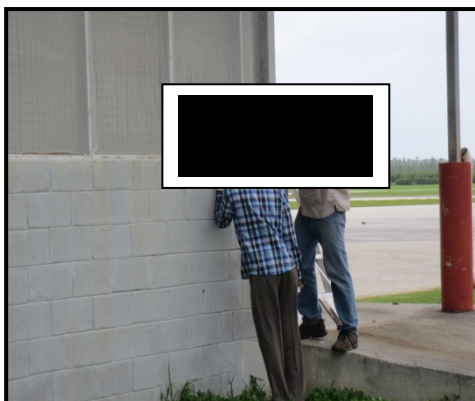
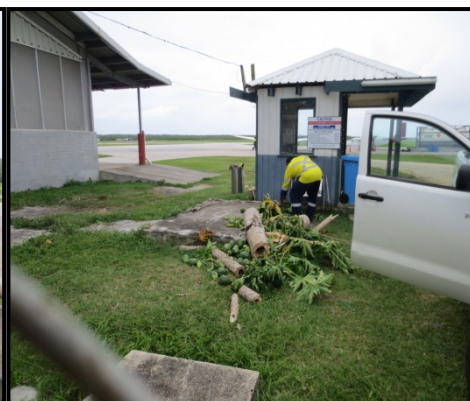
- 7.2 There was a crack observed on the wall of the quarantine area next to the exit door to the airport area. The crack could be seen from a distance and poses a possibility for fruit flies and other flying and crawling pests to enter through to the quarantine area and could potentially infest HTFA treated consignments.

Sealing of cracks and
removal of the papaya plant

- 7.4 Noted and agreed to the non compliance.
- 7.5 Thick layers of sealant were applied to the cracks by TEQM under the supervision of QQMD inspectors.

- 7.5 The sealing of the cracks was inspected and verified by MPI.

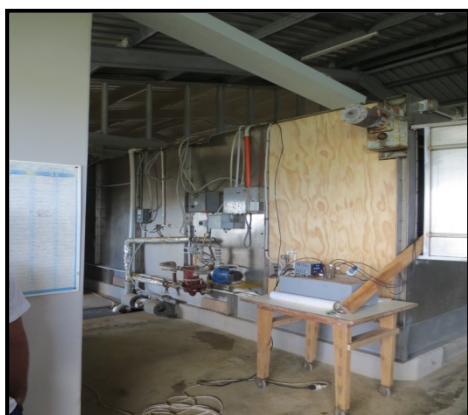
- 5.2 QTI has also reported about the left chamber being subjected to the direct effects of cold winds due to the way the building is currently designed. As a result of this, with reference to the cold spot mapping attached to the report by QTI, MPI has noted that house probe 4 is the probe likely to be affected much and confirms why probe 4 was the last probe to reach the kill temperature even though it was the lightest of all the probe fruits.

Wood panel fitted on the side of the
left chamber to help insulate the
chamber against cold winds.

- 5.4 As an immediate corrective action a wood panel has already been fitted on the wind facing section of the left chamber. This insulates the wind facing side of the chamber. Also as part of the HTFA project improvement items a proposed wood frame with polycarbonate shutters has been approved for installation on the airport facing side of the building. This is the direction of the prevailing winds. The installation is planned for February 2014.
