Operation
“Cracked maize”

Field Inspections
2004 – 2005

2004 - HSNO - 01

AGRIQUALITY OPERATIONAL REPORT

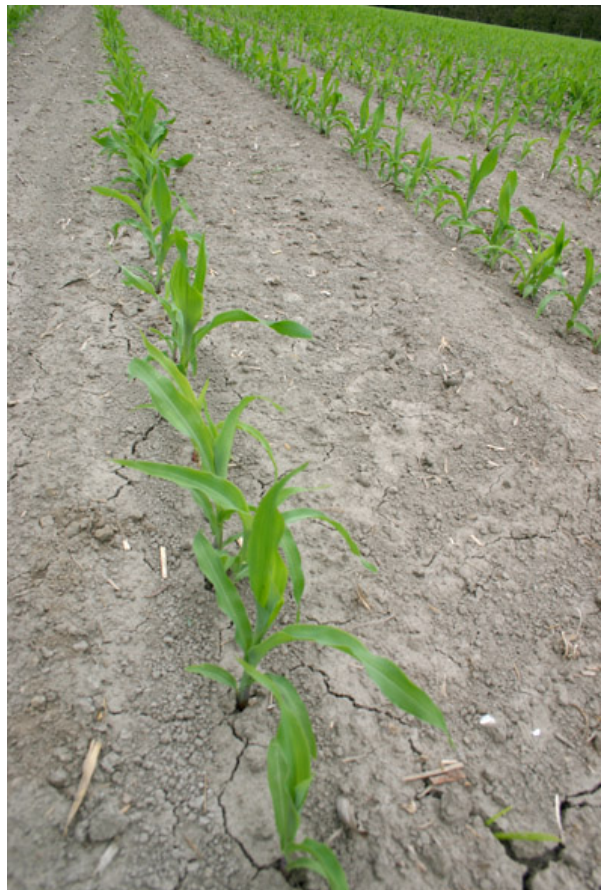
In each of the regions where the maize had been planted, field inspections were carried out within three weeks of emergence of the new crop. The new crop was easily discerned from the volunteers in the few cases they were present, due to the regular planting patterns (refer figure 2). Any plants not conforming to these patterns were assumed to be volunteers. Where volunteer plants were found they were mainly a result of the burial of whole or part cobs and were mostly multiples (bunches) as can be seen in figure 3. Although not seen in these inspections, other indications of volunteer plants include differences in:

Figure 2. Close up of typical plants at the time of inspection

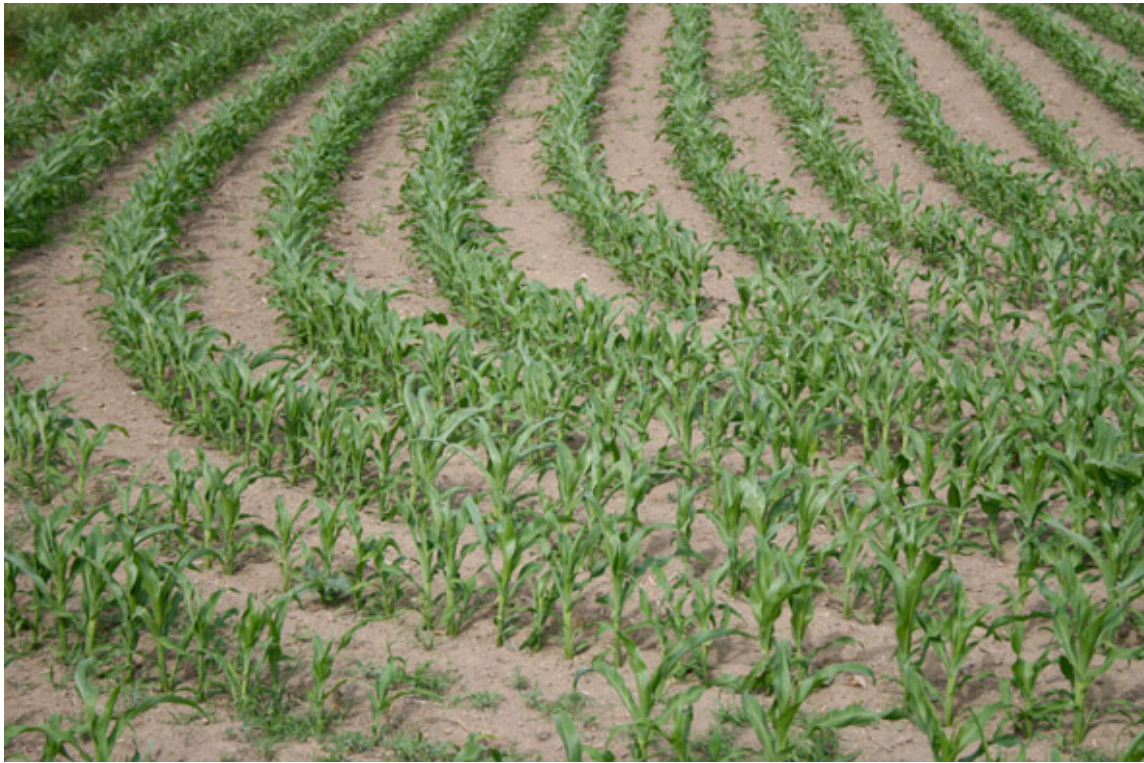
Figure 3. Larger plants with some weed growth present

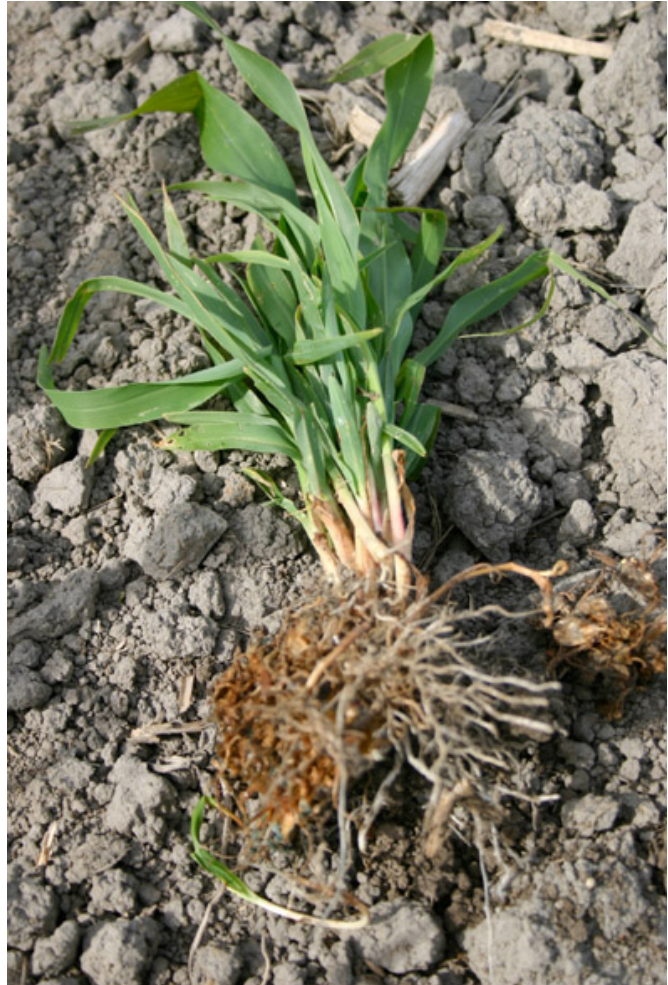
Figure 4. Volunteers still attached to cob, having emerged as a group of plants.

The paddock was replanted in maize for grain on 14 November 2004. When the field inspection was carried out on 2 December 2004, volunteers were found and removed (ref. figure 4). The volunteer plants were spread across an area of approximately 15m² were located at the margins of the two areas that were previously mulched and were the result of buried cobs (ref. figure 3). The paddock was mechanically cultivated and side dressed three weeks later as part of the normal management practice.

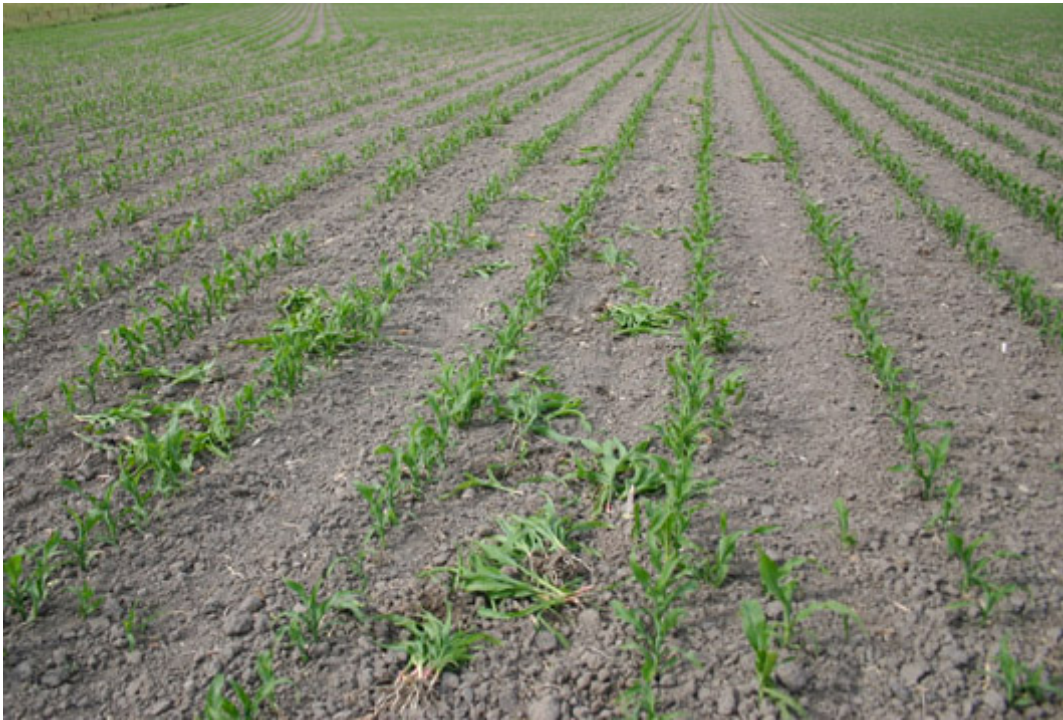
Figure 5. Photo showing size of volunteers at stage of removal.
