MINISTRY OF FISHERIES
Te Taitiaki i nga Hiri a Tangaroa

Operation Mega

Operation Orders

September 2008

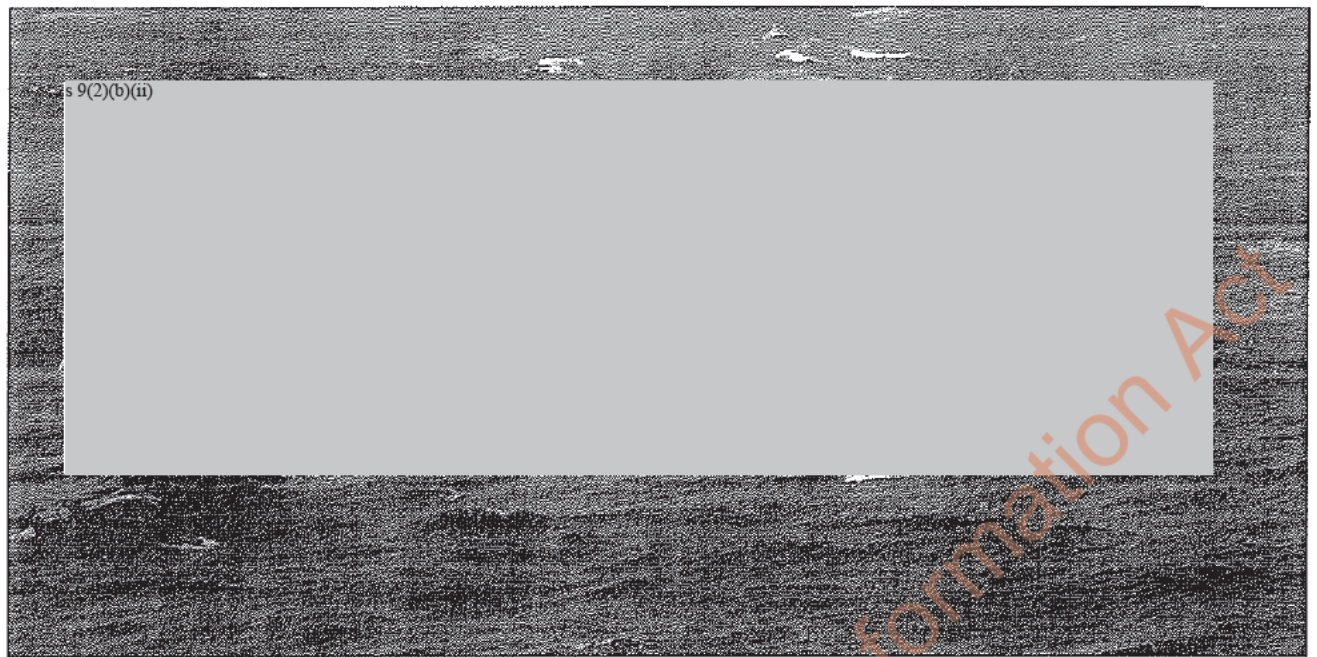
NZO 500 – 22 July 2008:

The photographs show the Buoys stowed and the fact the vessel is fishing.

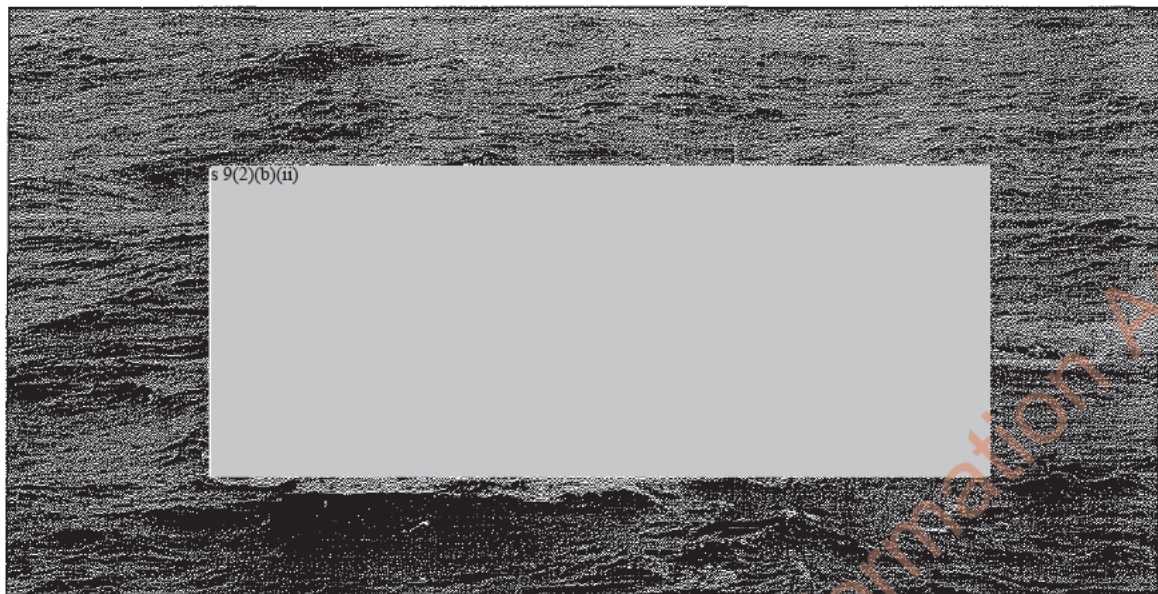
NZO 500 – 22 July 2008:

at about 0928 hrs showing buoys now deployed

Buoys now gone
from stern gantry

at about 0928 hrs close up on stern showing buoys now
deployed

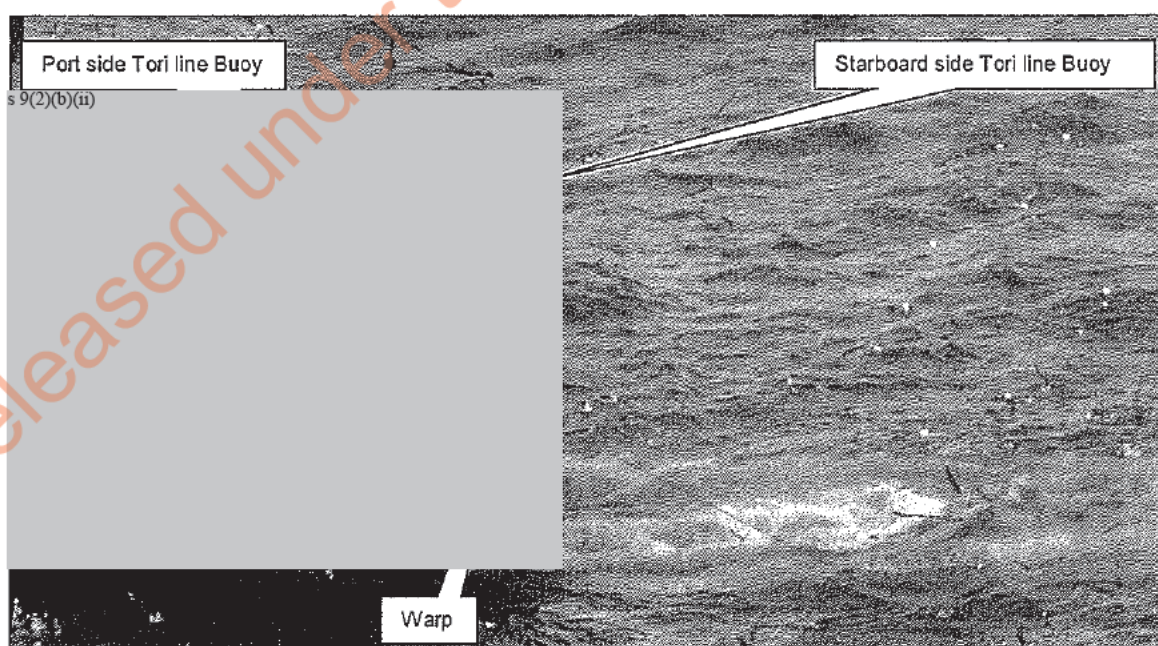
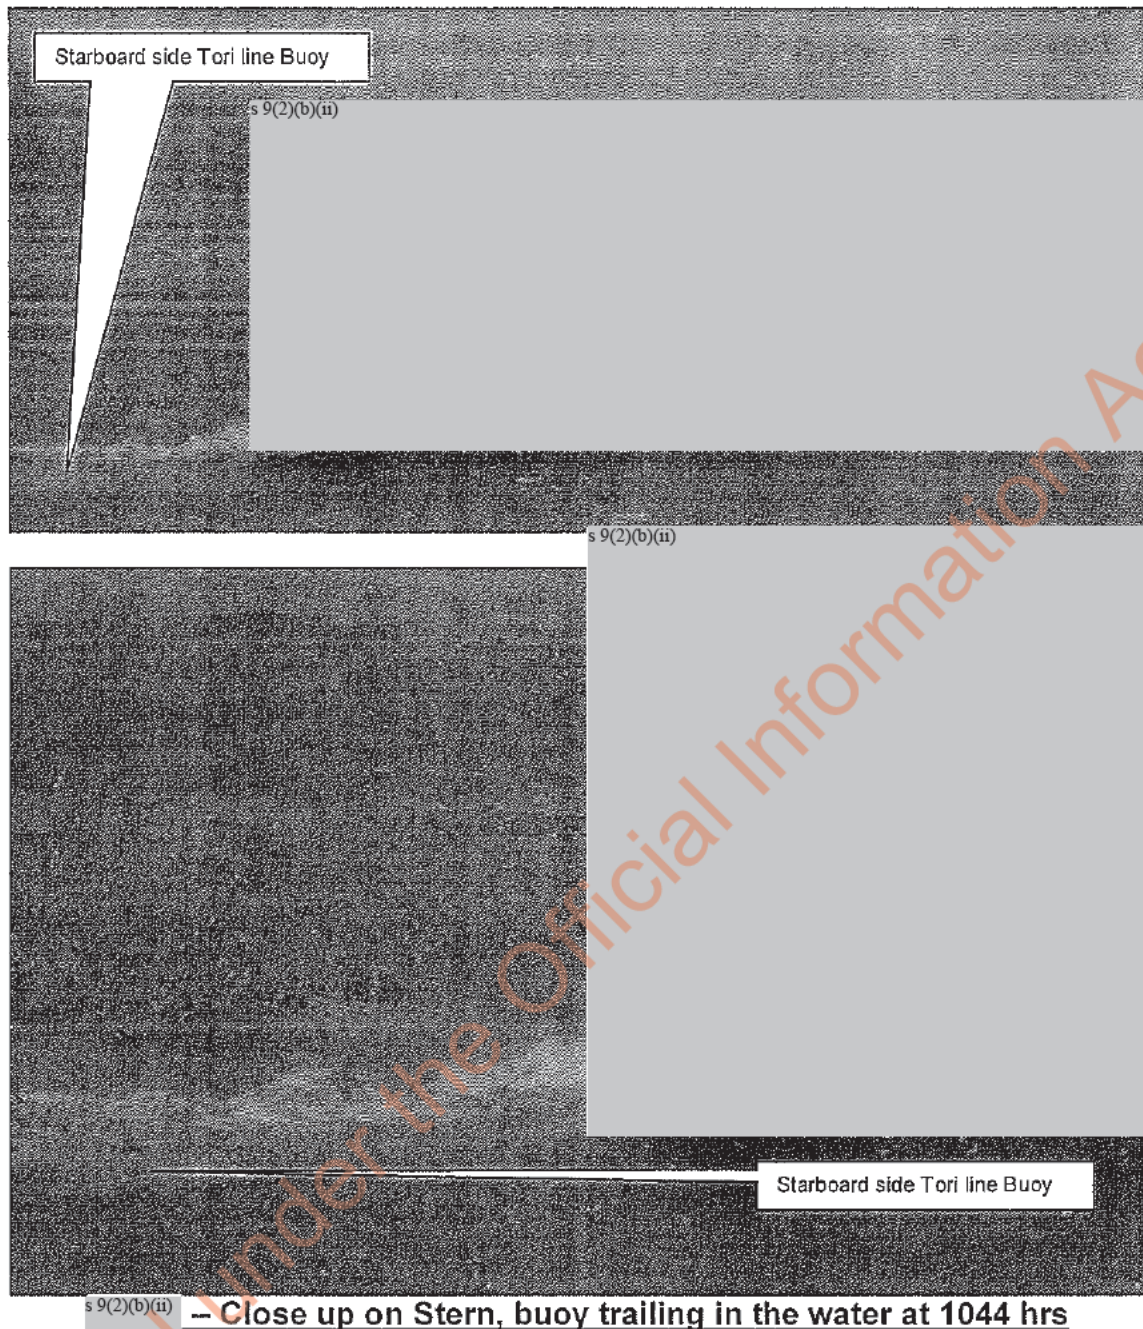
NZO 214 – 11 July 2008:

at 1401 hrs

- Close up on Stern

s 9(2)(b)(ii) – Close up on Stern at 0940 hrs

The photographs show the Buoys stowed and the fact the vessel is fishing on both the 11th and 22nd of July 2008. Photographs at 1044 hrs on the 23rd of July 2008 show that the vessel is capable of fishing with the buoys deployed as is required.
