# Final Workshop Report

## Orca Capture Incident Workshop

Workshop held in Wellington, New Zealand on 16 February 2018  
MPI Technical Paper No: 2018/02

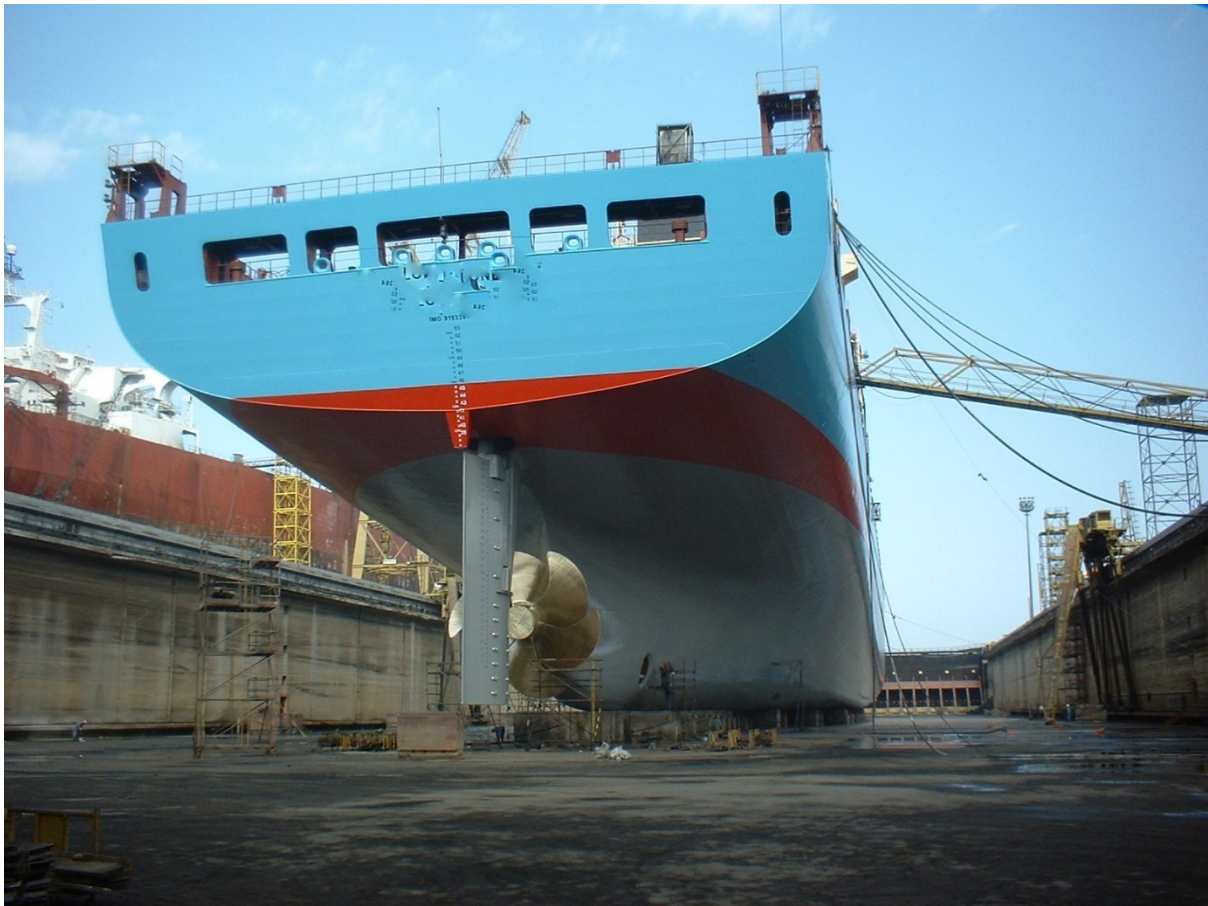
**Figure 4: Example photograph showing propeller/ rudder size and configuration for a shipping container vessel of comparable size (292 m) and build to other vessels known to have traversed the location of the orca capture 10-50 hours prior to the capture event. (Note that this is not one of the actual vessels known to have traversed the area, because drydock photos of these particular vessels were not available.)**

- Injuries #1 and #5 were most likely caused by a very large propeller, with wide diameter (e.g. 6+ m) and a (relatively) slow rotation speed, such as from a container vessel or large cruise ship. In forming this position, workshop attendees examined photographs of the propeller size and configuration on container ships comparable to those known to have been in the area in the period preceding the capture (see Figure 4).

- Injuries #2 and #4 may have been caused by post-mortem interaction with metal components of the trawl gear (e.g. bridles) on the ocean floor.
- Injury #3 is suggestive of a high-speed impact against a sharp object from a forward angle. This could have been caused by collision with a large rudder fin after the body passed through a propeller (e.g. Figure 4).
