Vessel biofouling as a vector for the introduction of non-indigenous marine species to New Zealand: Slow-moving barges and oil platforms

Biosecurity New Zealand Project ZBS2005-02

MAF Biosecurity New Zealand Technical Paper No: 2010/12

Prepared for Policy and Risk Directorate by the
Cawthron Institute

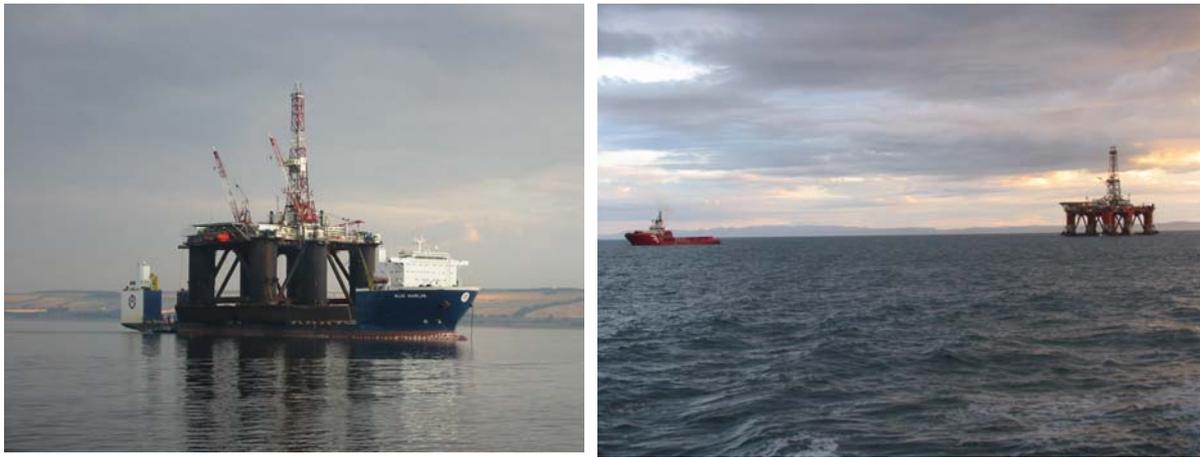
Figure 1: The semi-submersible drilling rig *Kan Tan IV* onboard a heavy lift vessel (left), and the semi-submersible drilling rig *Ocean Patriot* being towed in-water (right).

Various national and international companies manage the deployment of oil rigs in New Zealand, with Australia and Singapore being the most common source regions in recent years. Rigs are either dry-towed to New Zealand onboard a heavy lift vessel or towed in-water by supply vessels (Figure 1).

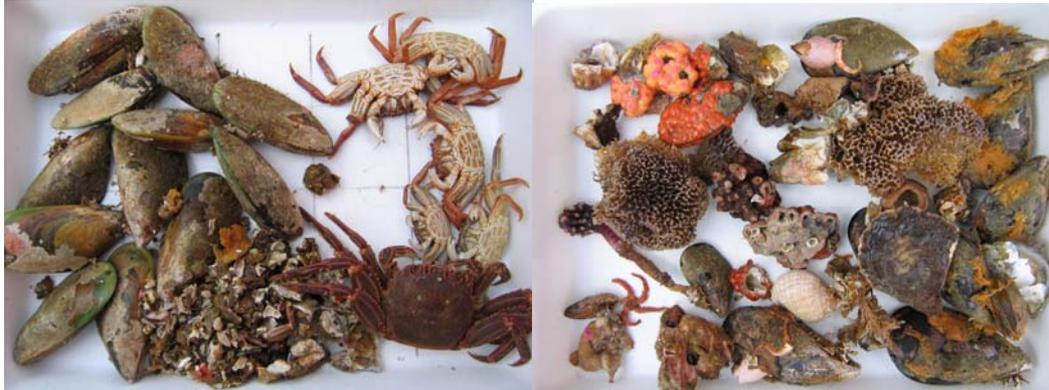
Figure 18: Sessile and mobile fouling organisms collected from the hull of the semi-submersible drilling rig *Ocean Patriot* during an inspection off the Taranaki coast (G. Hopkins, unpublished data).

The discovery of the South African brown mussel (*Perna perna*) on the *Ocean Patriot* is a recent example of an oil rig transporting NIS. Taxonomic verification of the presence of *P. perna* occurred while the rig was being defouled in Tasman Bay, prior to relocation to Australia. Concerns regarding the effects of *P. perna* on New Zealand's green-lipped mussel industry and on the environment led to a major campaign to remove the defouled material from the seabed (Hopkins et al. *in prep*). NIS colonisation of platforms in transit to New Zealand have also been described. Foster & Willan (1979) found six species of barnacle that had not previously been recorded in New Zealand on parts of the *Maui A* platform that were constructed in Osaka, Japan. A further six species of tropical barnacle that likely settled while the platform was in transit via New Caledonia and the Solomon Islands were also documented. However, a later investigation of the platform found only dead barnacle tests of the tropical species, suggesting they had not survived in the cooler temperate waters off the Taranaki coast (University of Auckland 1982).
