Assessment of Preventative Biofouling Management Measures

MPI Technical Paper No: 2016/69

Prepared for Ministry for Primary Industries
By ESLINK Services

September 2016

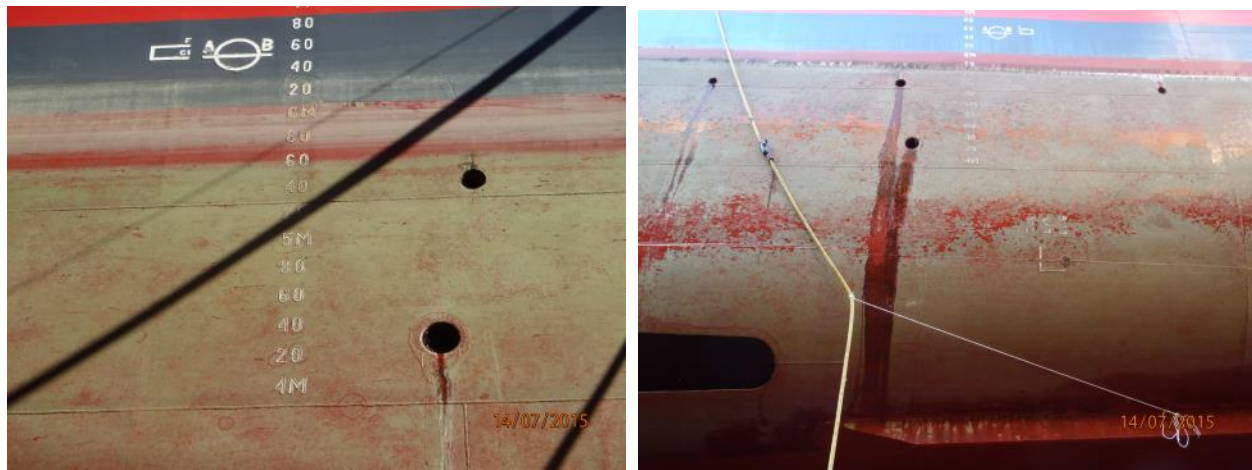
Figure 5. FRC on boottop and vertical sides at 23 months with only slime (primary biofouling).

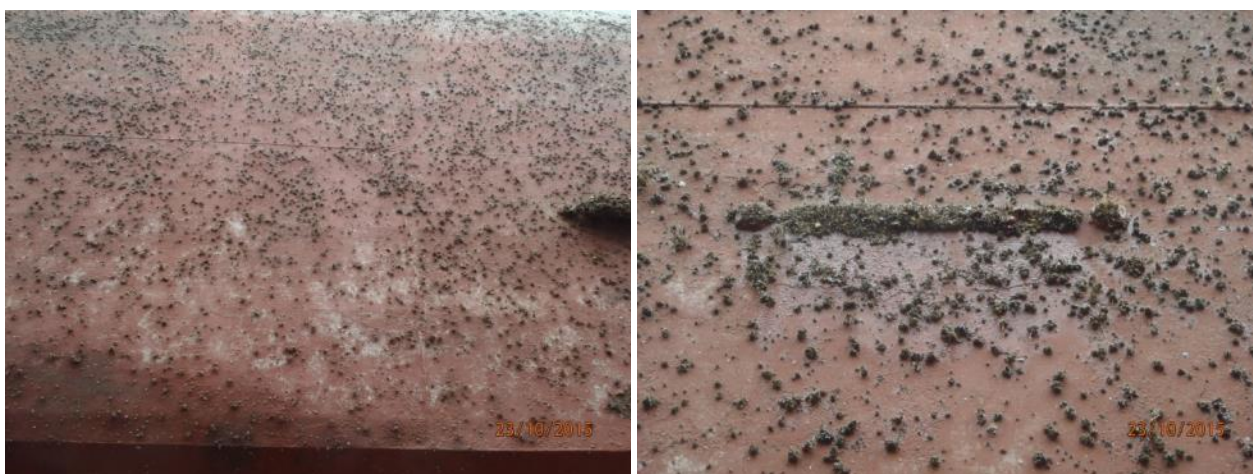
Figure 8. Barnacle fouling on CDP coating of one vessel at 7 months.

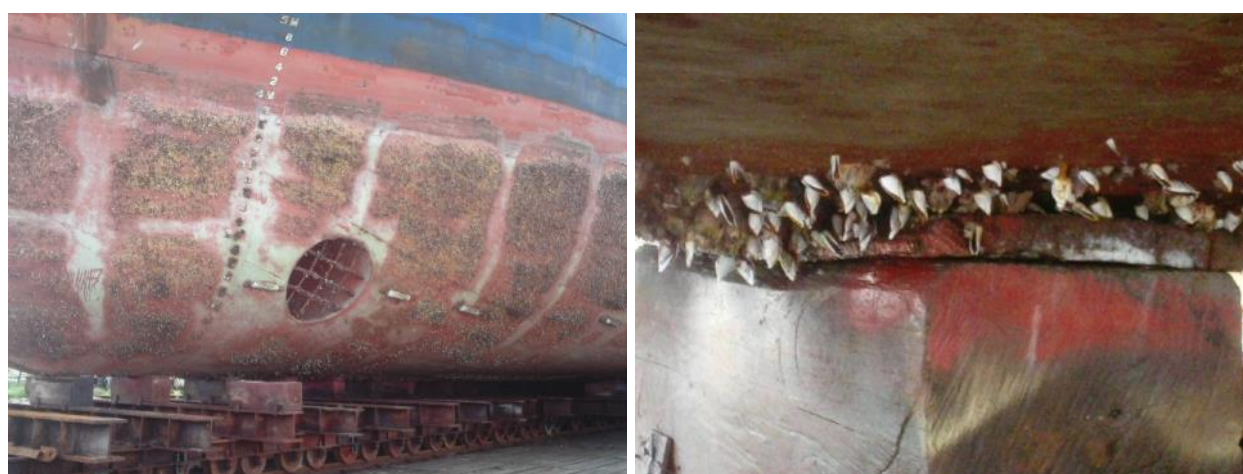
Figure 9. Scattered patches of goose and acorn barnacle fouling on CDP coating on one vessel at 15 months.

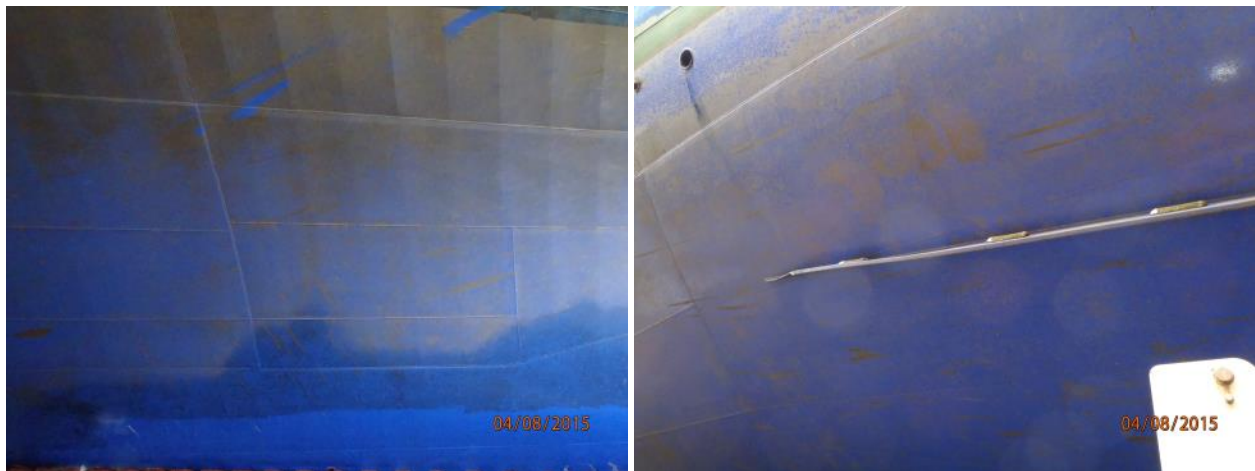
Figure 12. FRC at 36 months with only light slime.

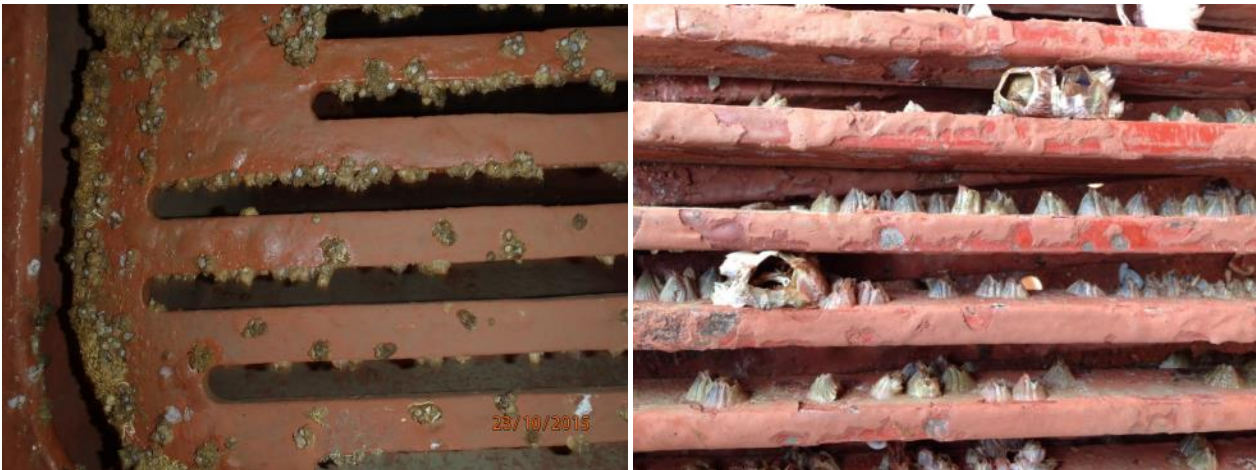
Figure 17. CDP-coated sea chest intake grates on vessels after 7 (left) and 15 (right) months service with acorn barnacles predominantly clustered along grate edges and between bars.

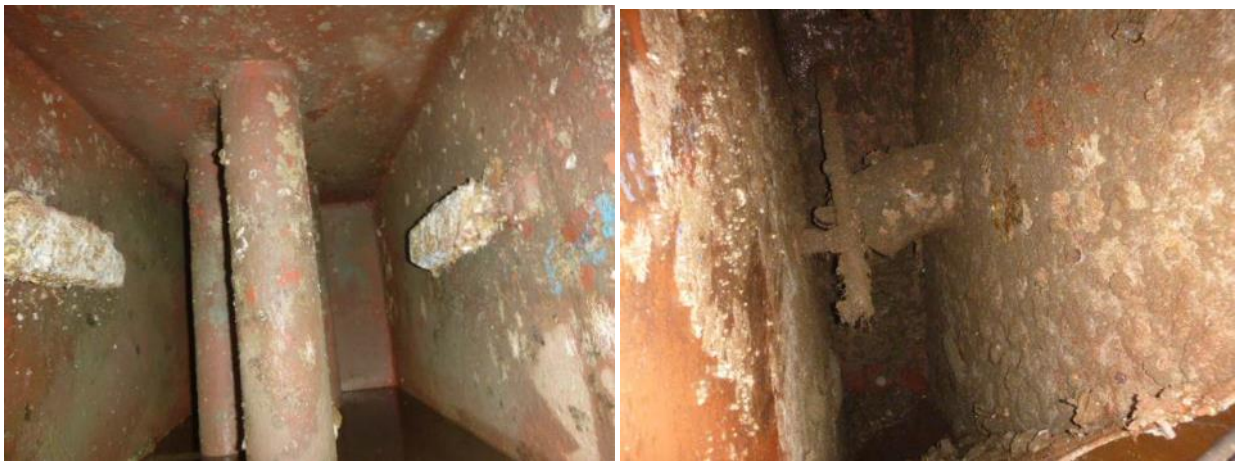
The one vessel with sea chests painted with CDP2 was inspected by the PI and, although the in-service period for this vessel was only 15 months, the extent of biofouling (Figures 27, 32) was as great or greater than that typically seen in sea chests painted with CDP1 paints on vessels after longer in-service periods (Figures 27, 29-31).

Figure 29. CDP1-coated sea chests on one vessel at 30 months showing extensive biofouling cover on walls and projections.

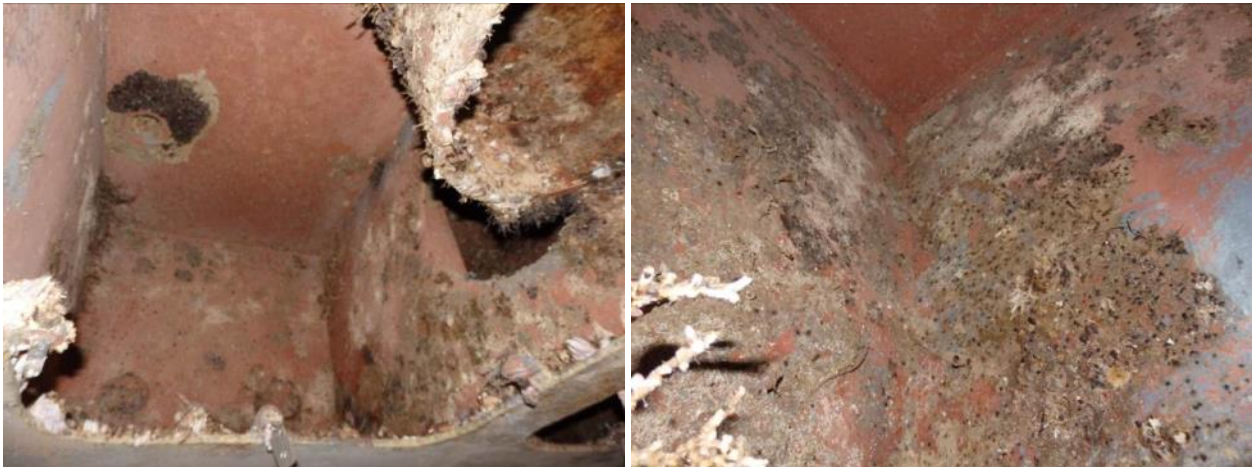
Figure 30. CDP1-coated sea chests on one vessel at 36 months with extensive fouling on chest walls.

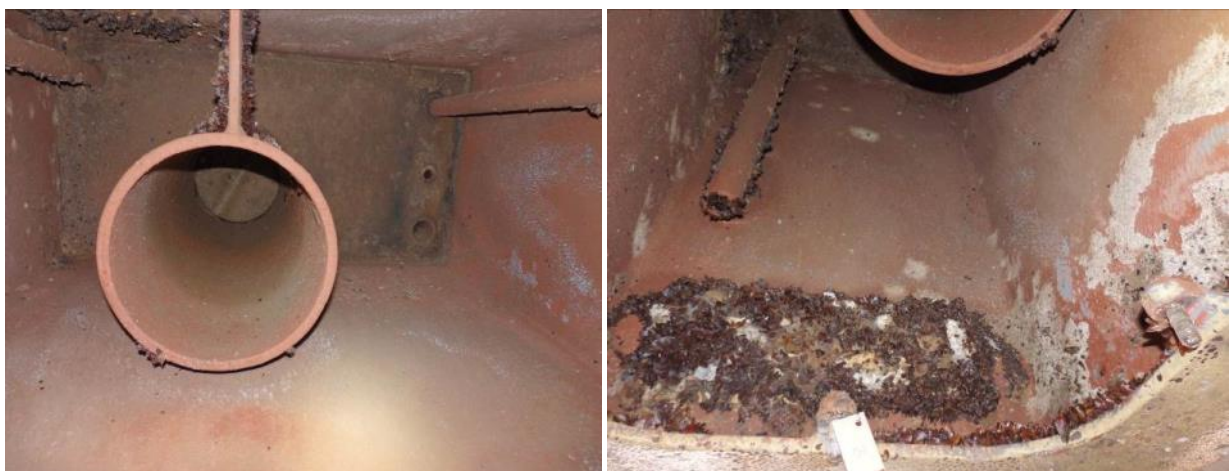
Figure 31. Other CDP1-coated sea chests on the same vessel as in Figure 30, but macrofouling mostly restricted to projections.

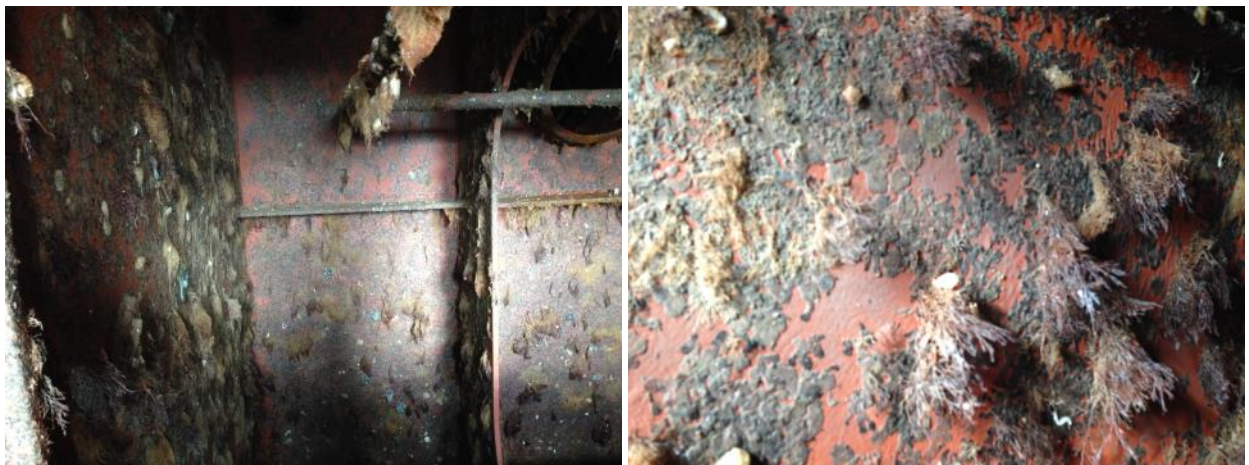
Figure 32. CDP2-coated sea chest at 15 months with walls almost completely covered by bryozoans and other macrofouling.

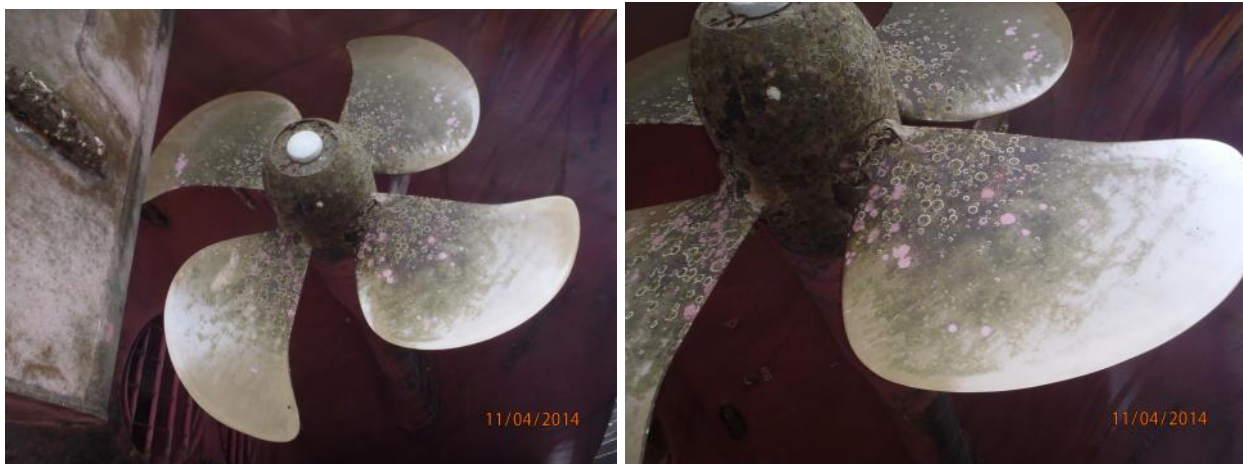
The unpainted propeller shows a typical fouling pattern for propellers, with the cover of encrusting fouling organisms on the blades increasing inwards from the tips toward the hub (Figure 45). Highly turbulent water flow and cavitation would prevent growth near the blade tips. The FRC is eroded by turbulence near the blade tips (Figure 46) but inner faces are maintained free of attached biofouling.

Figure 45. Unpainted propeller with low-profile macrofouling on the hub and inner surfaces of blades.

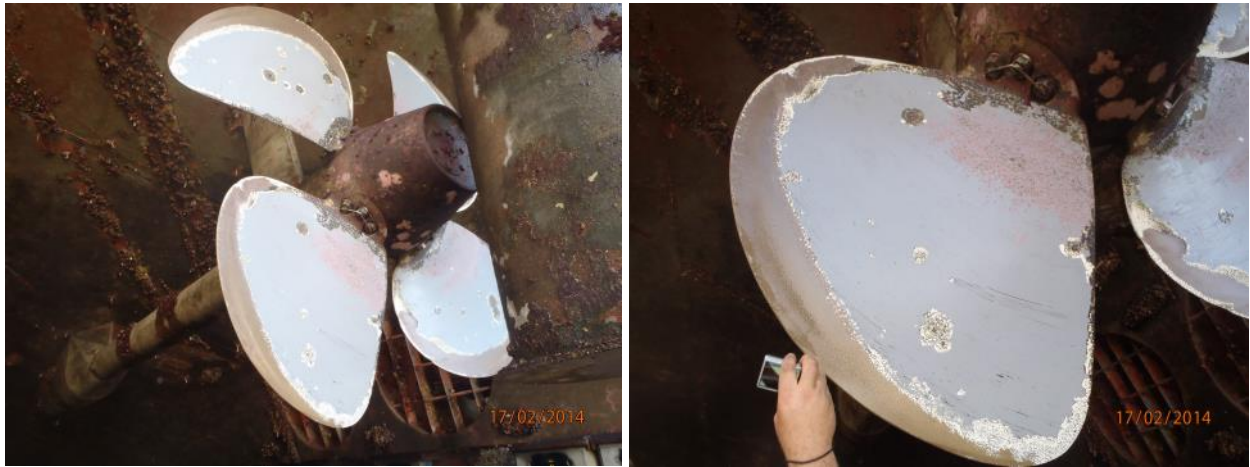
Figure 46. FRC-painted propeller on a vessel with a similar operating profile to that in Figure 43 showing absence of comparable macrofouling on the blades.

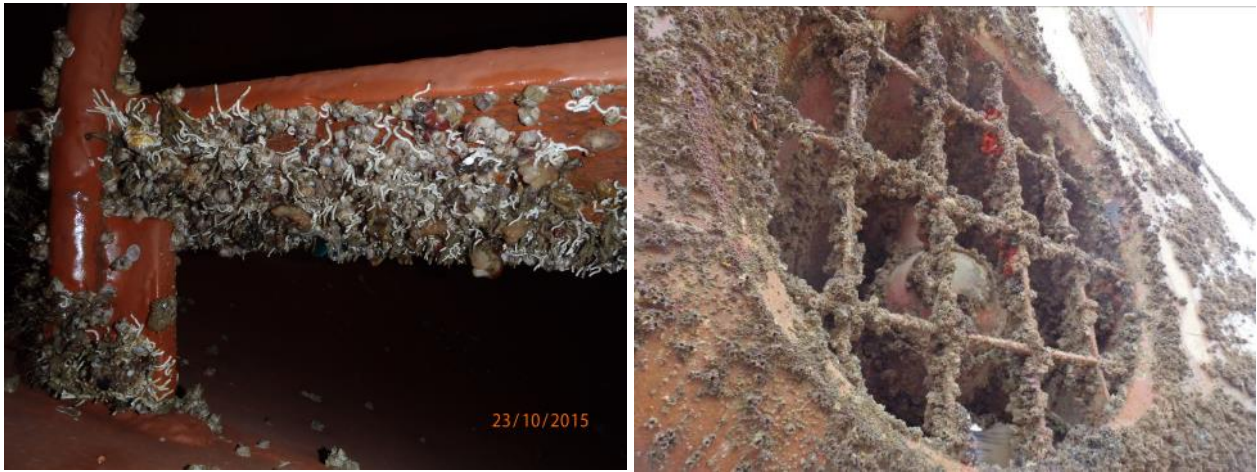
Similar observations to rudders were made on the performance of paints applied inside thruster tunnels and to the tunnel grates. Substantial accumulation of fouling was seen on these when painted with CDP coatings (Figures 47, 48), but substantially less when FRC was applied (Figure 49).

Figure 48. CDP painted thruster tunnel grates on two vessels after 7 (left) and 36 (right) months in service showing substantial macrofouling establishment on grate bars.

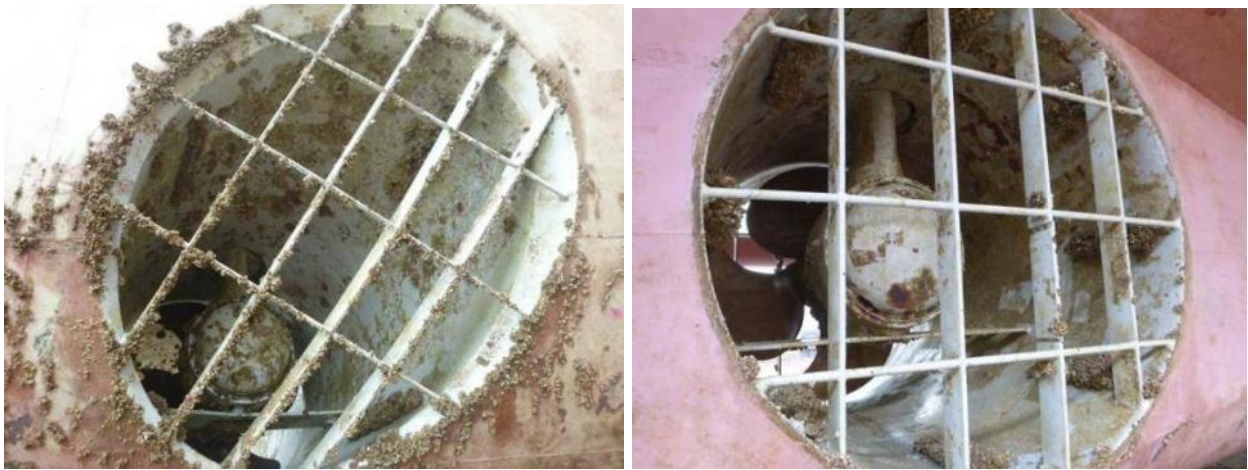
Figure 49. FRC-painted thruster tunnels and grates on one vessel after 17 months showing minimal to little macrofouling on grates.

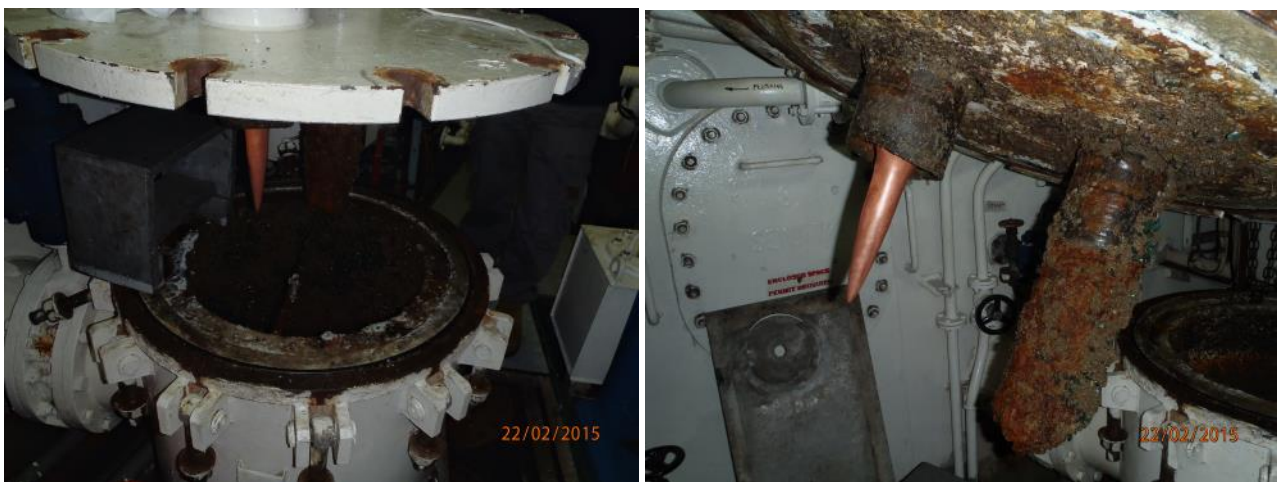
One of the vessels inspected during this study had an operating copper anodic system with anodes fitted to the lids of both the high and low seawater intakes and these had been operated in accord with the manufacturer's operating manual (Figure 65). When inspected, seawater had been drawn continuously for several weeks through the high intake, with the low intake closed off. When opened, the strainer box and strainer basket were infested with juvenile Asian green mussels (AGM; *Perna viridis*), which demonstrated that the MGPS was providing no fouling control (Figure 66). In contrast, no living organisms were present in the low sea intake strainer box, and the water appeared anoxic (Figure 67). Although the MGPS was still operating, the stagnation of the water was considered most likely to be the lethal factor.

Figure 65. MGPS anodes fitted to the lid of a high intake strainer box.

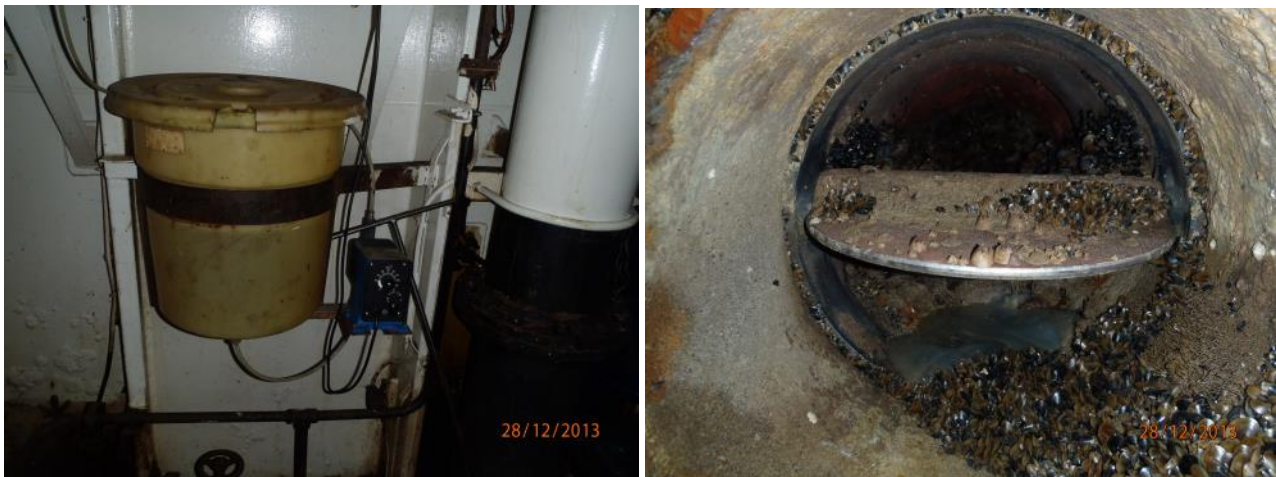
Dosing of internal seawater piping systems with a liquid “antifoulant” solution is considered an alternative to electrochemical MGPS. The system inspected drip-fed chemical through a dosing pipe in each of the port and starboard sea chests (Figure 68). When grates were removed the sea chests were found to be completely infested with blue mussels (*Mytilus planulatus*) (Figure 69). Mussels were also lining in the pipework inboard of the sea chests.

Figure 68. Chemical reservoir for dosing and hull isolation valve in the chemically treated system.

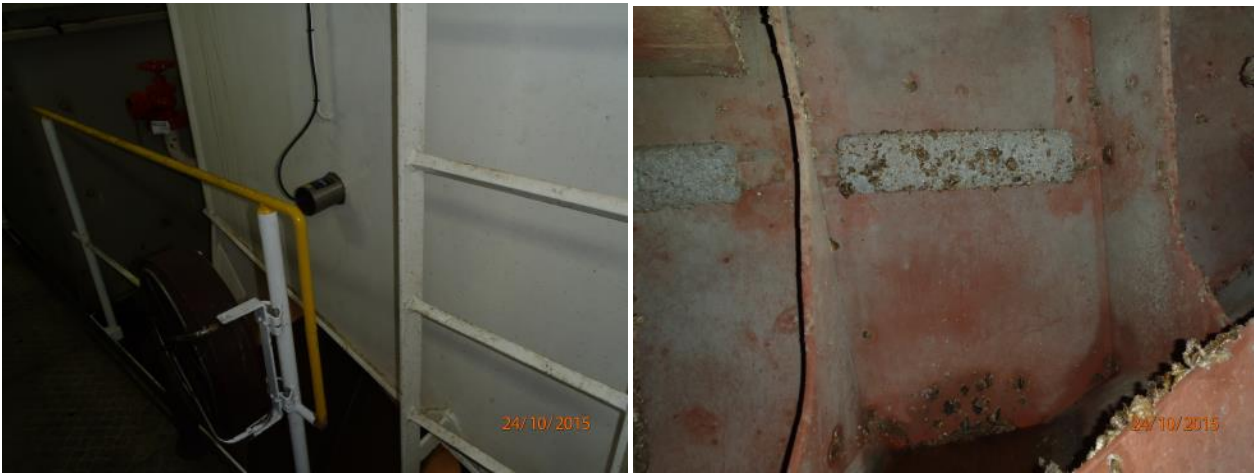
The box cooler sea chest on one inspected vessel was fitted with a sonic MGPS. Transducers were attached to the exterior of each wall accessible within the engine room (Figure 70, left), and one on the top of the box cooler. The inside walls of the sea chest were closely examined for any sign of variation in the biofouling at the transducer location, but none could be seen (Figure 70, right). The box cooler in this sea chest was heavily fouled (Figure 60).

Figure 70. Ultrasound generator attached to the outside of the sea chest and corresponding location inside the sea chest.
