Conduct of land-based biofouling surveys for domestic vessels

Biosecurity New Zealand Technical Paper No: 2020/03

This technical advice supports the development of criteria and processes for land-based biofouling surveys of domestic vessels.

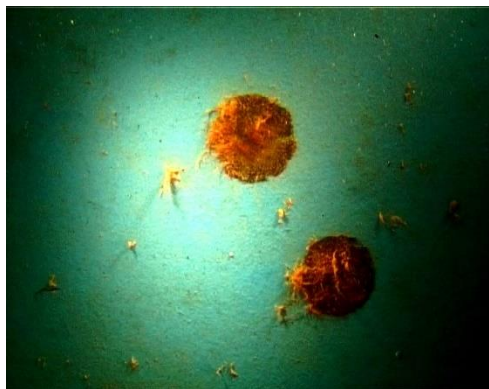
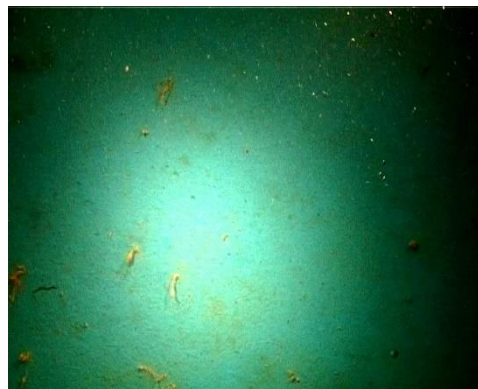
-
- 2 Light fouling. 1 – 5 % of visible surface covered by very patchy macrofouling or filamentous algae. Remaining area often covered in slime. Examples below show presence vs. absence of fouling in two adjacent areas of a hull (low LoF overall).

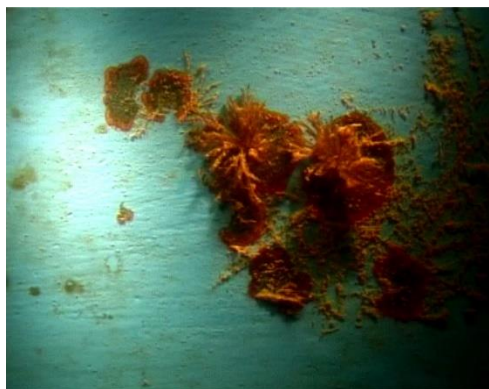
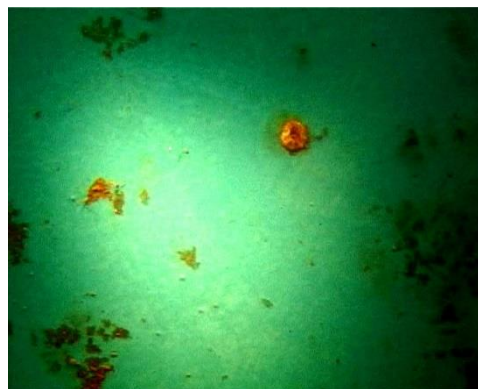
-
- 3 Considerable fouling. Macrofouling clearly visible (usually > 1 species) but still patchy. 6 – 15 % of visible hull surface covered by macrofouling or filamentous algae. Remaining area often covered in slime.

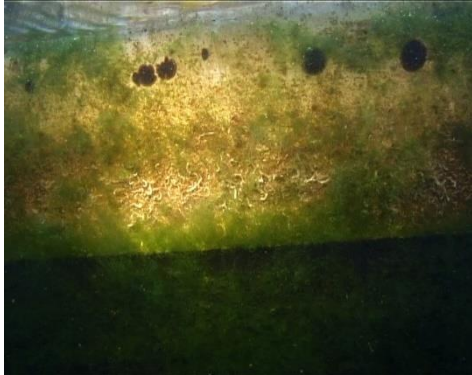
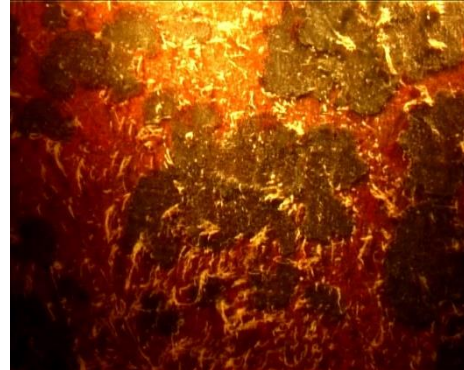
-
- 4 Extensive fouling. 16 – 40 % of visible hull surface covered by macrofouling or filamentous algae. Remaining area often covered in slime.

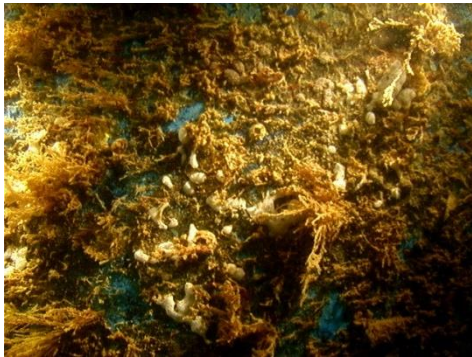
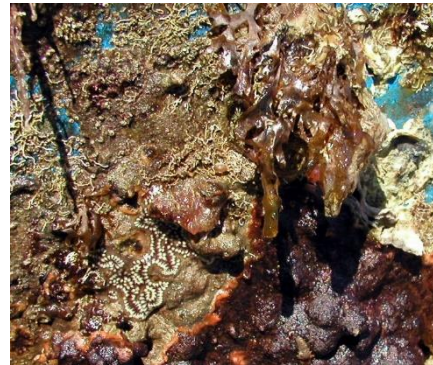
-
- 5 Very heavy fouling. 41 – 100 % of visible hull surface covered by macrofouling or filamentous algae. Remaining area often covered in slime.

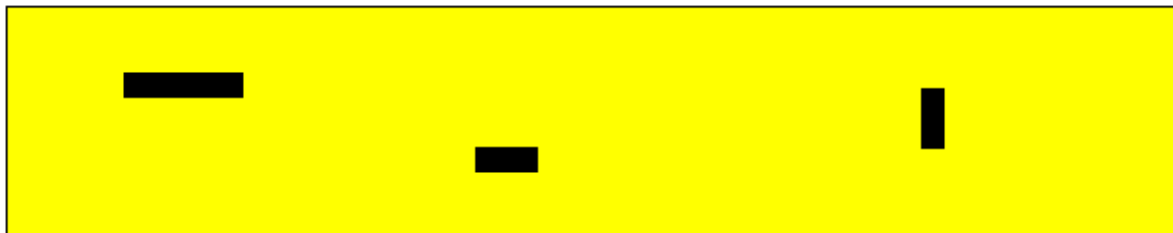
Fouling extent diagram – 2 % localised fouling.

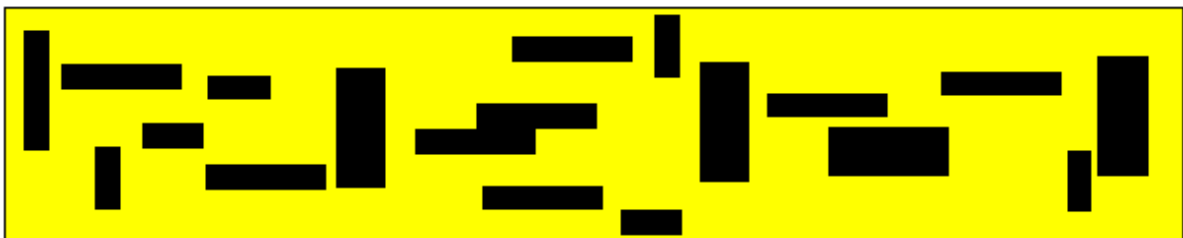
Fouling extent diagram – 20 % localised fouling.

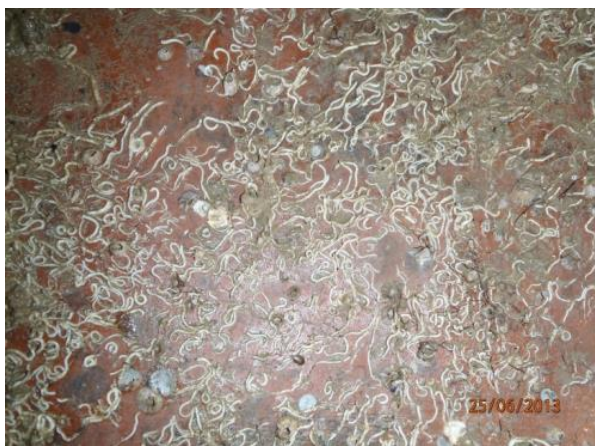
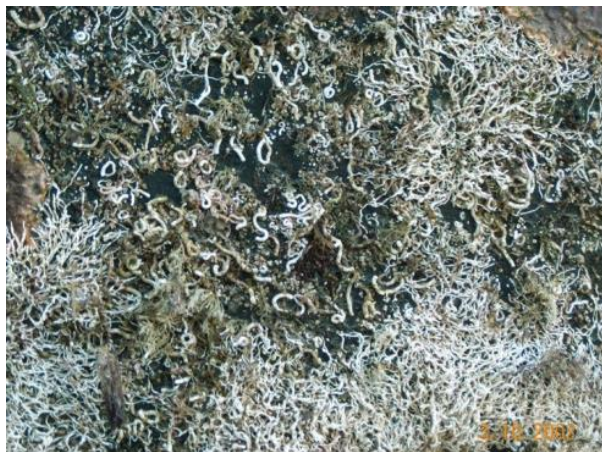
Tubeworms

Description: White, or sometimes brownish, calcified tubes with the lower surface cemented to the substrate and an opening at one end through which the worm extends tentacles to feed; tubes elongate and sinuate, or tightly coiled; fully adherent along the length of the tube, or the outer end extending out from the substrate when populations are dense. Uncalcified tubeworms can have grey, leathery tubes, or mucilaginous tubes consolidated with sand or silt particles.

Tube-building polychaetes	<ul style="list-style-type: none"> Structure: generally intact (body usually within tube), not crushed, no holes or gashes, and natural colour (pigmentation). Care needed, as regeneration from lesser fragmentation is possible with some taxa. Feeding/movement: worm retracts into tube when touched, and/or feeding structures (tentacular crown) visible and moving. Feeding or respiration currents visible. 	<ul style="list-style-type: none"> Structure: tube missing, loss of tentacular crown, body badly crushed or lacerated, no soft tissues or tissues decomposing. Complete loss of pigmentation. Feeding/movement: feeding structures may be visible, but no movement or reaction to touch. No feeding or respiration currents visible.
Sponges	<ul style="list-style-type: none"> Structure: fragments retain natural colour, firm texture (don't fall apart). Sponges retain a "fleshy/translucent/shiny" appearance. Look for "translucent" tissue between fibres. Feeding/movement: extremely difficult to observe. Feeding or respiration currents visible. 	<ul style="list-style-type: none"> Structure: colony/fragment faded and bleached, falling apart. Complete lack of pigmentation. Sponge a mass of golden fibres/hair-like structures without "translucent fleshy tissue" between the fibres, or decomposing tissues. Feeding/movement: extremely difficult to observe. No feeding or respiration currents visible.

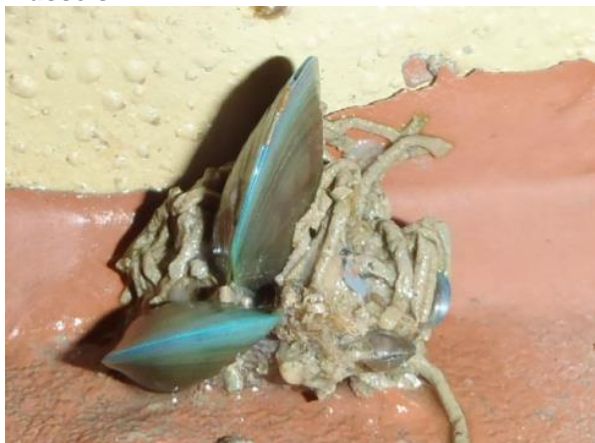
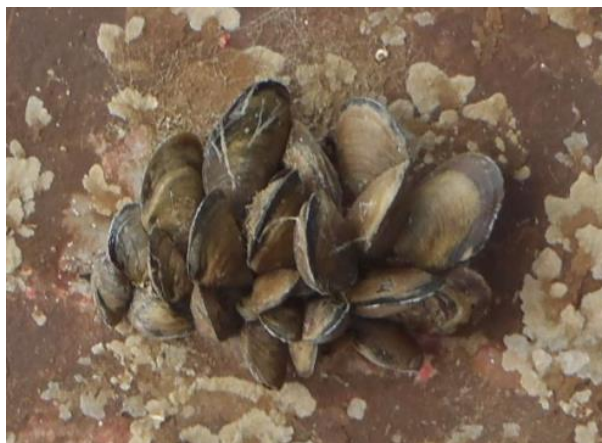
Mussels

Description: Bivalve molluscs with the paired, similar, approximately wedge-shaped shells attached to the surface by a bundle of byssal threads ("beard") that protrude from between the shells close to the base.

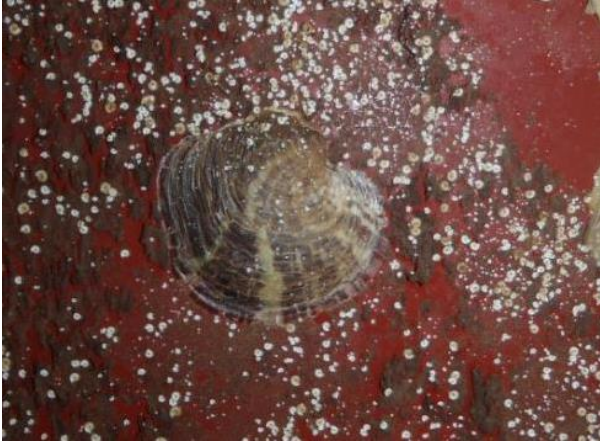
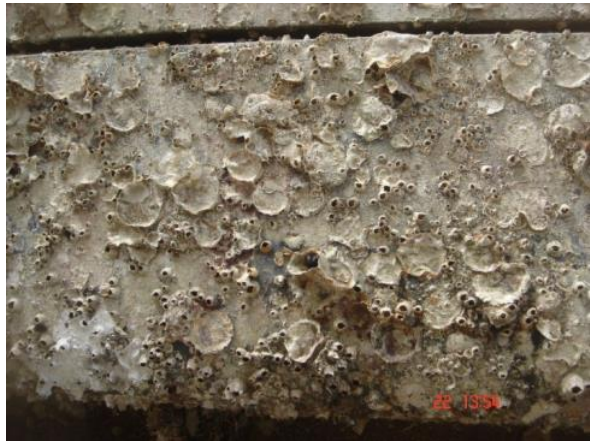
Oyster and oyster base plates

Description: Bivalve molluscs with one of the shells completely, or nearly completely, cemented to the surface and the upper shell hinged to the lower at one end. Lower, strongly adherent shell often persisting after the animal has died and the upper shell detached.

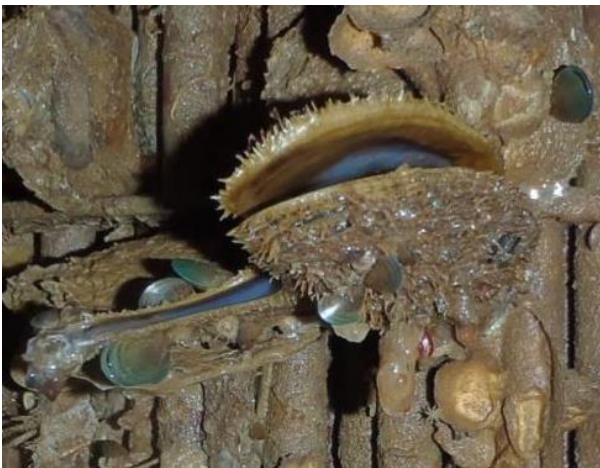
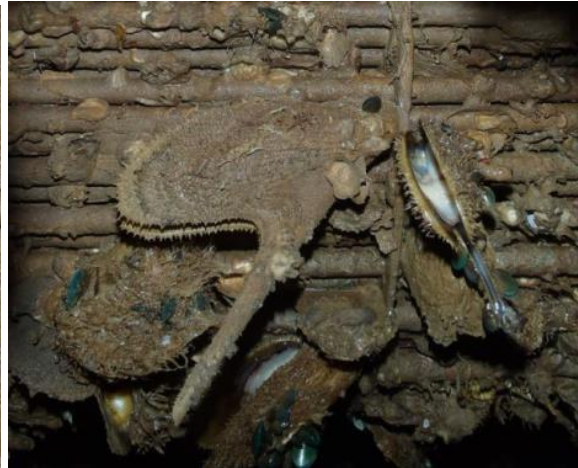
Bivalves – other

Description: Bivalve molluscs of different shapes and forms to mussels and oysters and attached by either byssal threads or leathery ligaments, or free-living between other fouling organisms.

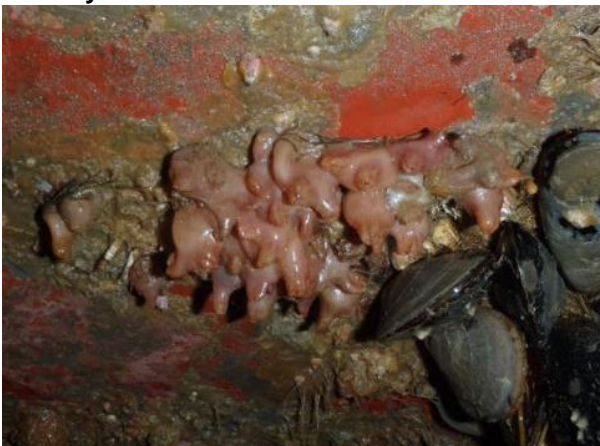
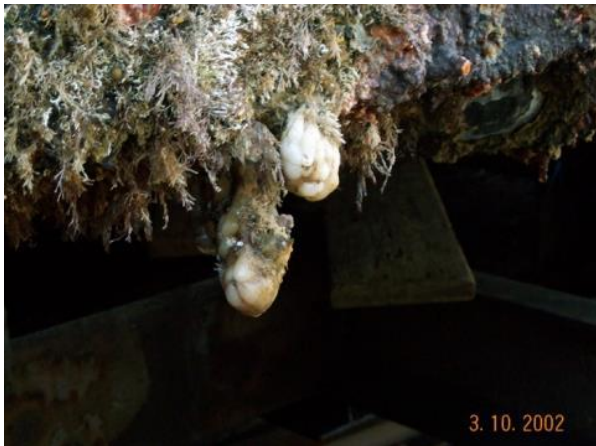
Solitary ascidians

Description: Leathery pigmented or translucent sac-like organisms that lack any calcification and with two openings ("siphons") at the outer end for drawing in and expelling seawater; the latter giving the common name "sea squirts". Can grow singly or in clumps.

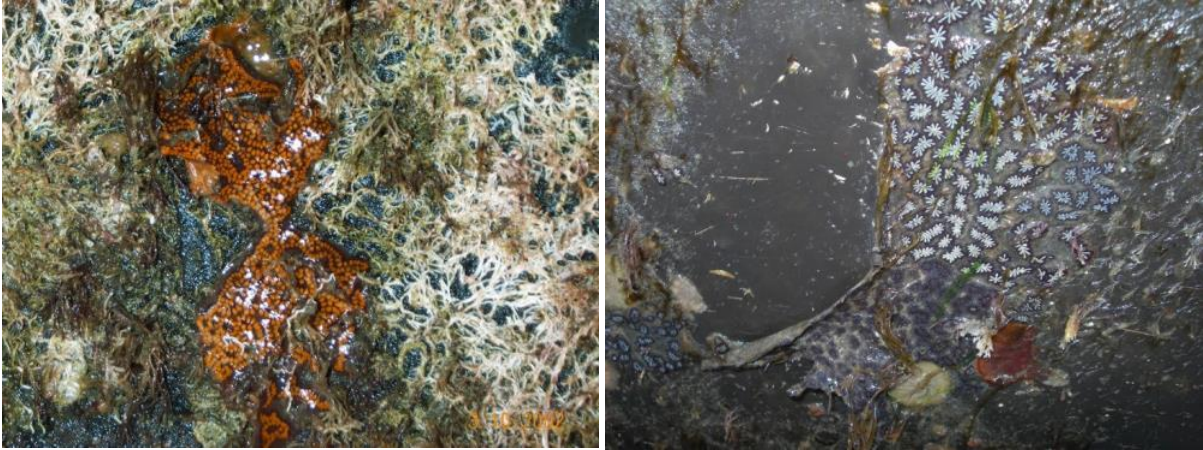
Description: Encrusting colonies of zooids, each structured like a minute solitary ascidian, within a clear or pigmented mucilaginous or leathery matrix and often arranged in linear series or star-like patterns; sometimes with dense aggregations of white calcareous particles distributed uniformly through the enveloping matrix.

Colonial ascidians	<ul style="list-style-type: none"> Structure: Colony/fragment in reasonable 'shape', not entirely crushed, and natural colour (pigmentation). Several polyps intact. Feeding/movement: inhalant and/or exhalant siphons open, but close when touched. Feeding or respiration currents visible. 	<ul style="list-style-type: none"> Structure: Shredded or crushed so that badly damaged, no soft tissues visible or tissues decomposing. No polyps visible (polyps may have 'popped out' from mechanical pressure on colony). Complete loss of pigmentation. Feeding/movement: siphons open but no reaction to touch. No feeding or respiration currents visible.
Solitary ascidians	<ul style="list-style-type: none"> Structure: test (body) intact, no holes or gashes, not crushed flat or severely deformed, and natural colour (pigmentation). 	<ul style="list-style-type: none"> Structure: test badly damaged, crushed or deformed. Branchial basket exposed and/or damaged, gut system protruding from test, no soft tissues
